LORING AIR FORCE BASE, WEAPONS STORAGE AREA
Northeastern corner of the base at the
northern end of Maine Road
Limestone Vicinity
Aroostook County
Maine

HAER No. ME-64-D

WRITTEN HISTORICAL AND DESCRIPTIVE DATA

HISTORIC AMERICAN ENGINEERING RECORD

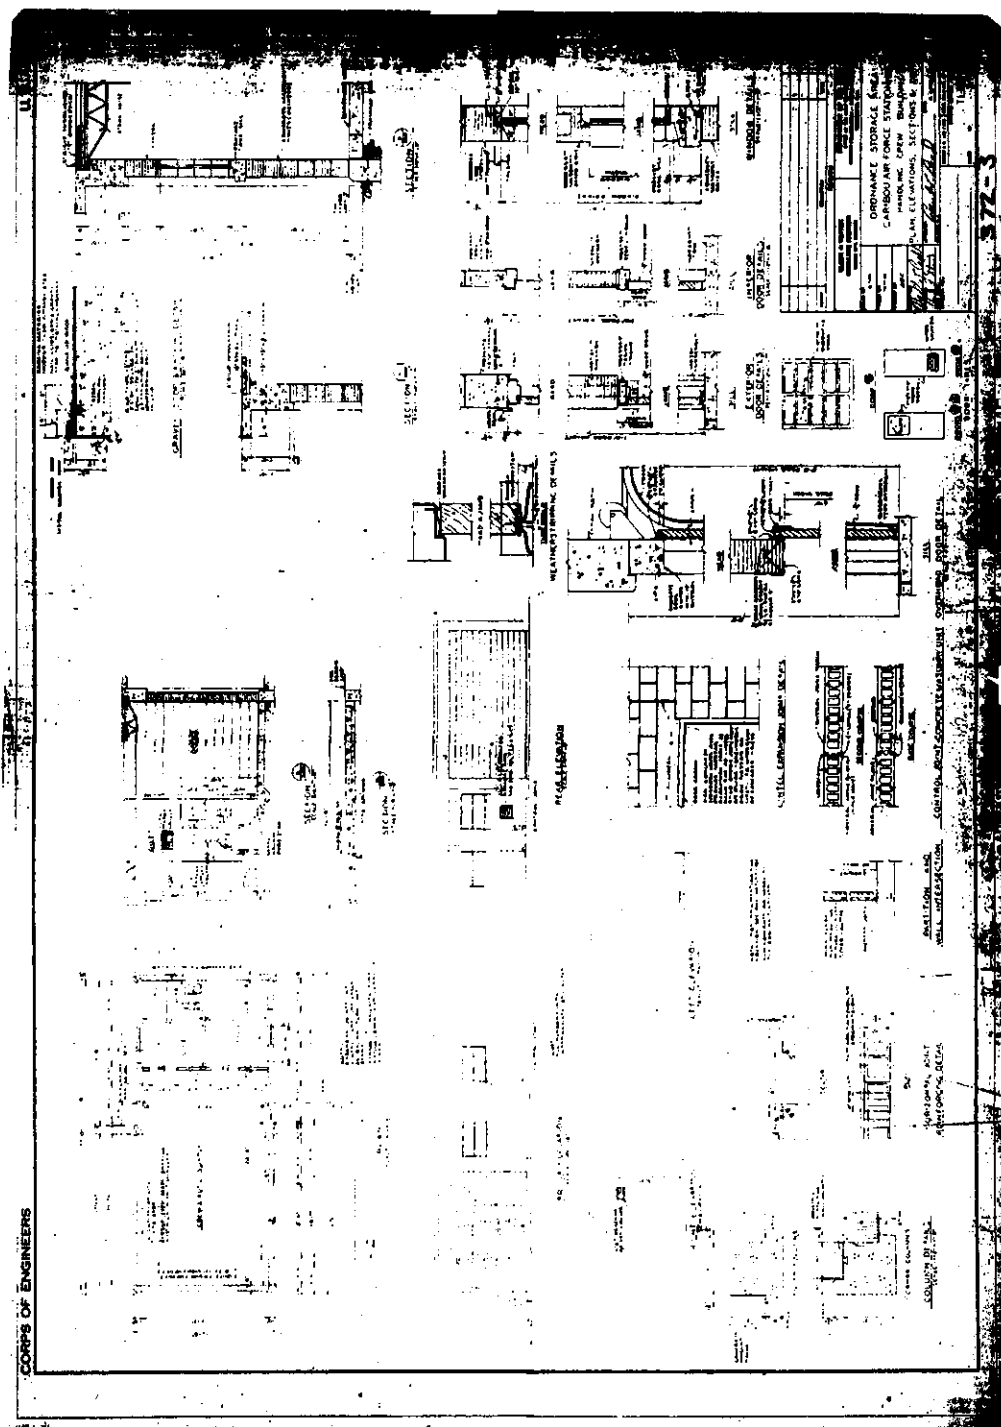
Construction drawing of plan, elevations, section, and details for Handling Crew Building (Building 372) in Base Spares Area, dated April 1, 1955. Drawing by Black & Veatch Consulting Engineers located at AFBCA, Loring AFB, Maine.

Building 372. Building 372 was constructed in 1956 of reinforced concrete throughout and is approximately 36 feet by 16 feet. It was used by the Readiness Crew, and for hazardous storage.

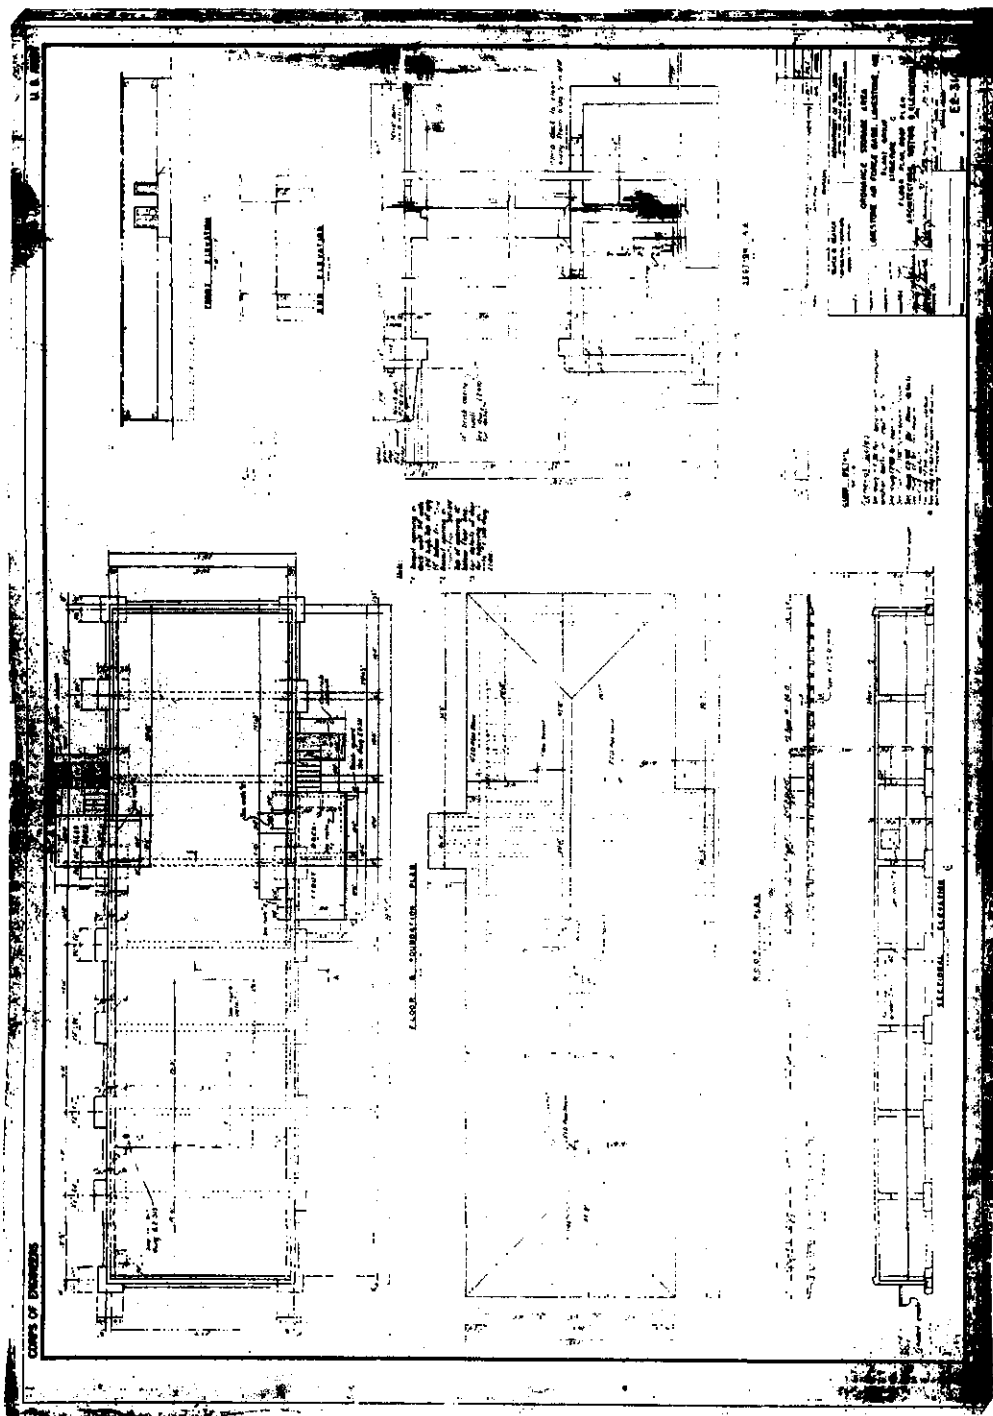
Construction drawing of floor and roof plans for Structure C (Building 260) in Storage Area, dated April 30, 1951, with revisions dated June 25, 1951. Drawing by Black & Veatch Consulting Engineers, located at AFBCA, Loring AFB, Maine.

Building 260. Building 260, also known as Storage Structure A, was designed to appear as a two-story structure; its second story was never accessible. The building is constructed of heavily reinforced concrete throughout. Its northern and southern elevations are blank. The western elevation appears to have three paired windows at both the first and second levels. These blind windows were never operable. The eastern elevation has a similar configuration of blind windows at the second level.

The first story of the eastern elevation has one blind window pair at the southern end and a projecting entrance at the northern end. At the entrance, a straight run of six concrete steps leads to a raised concrete platform that is sheltered by a flat roof. At the southern end of the platform is a concrete enclosure with a doorway. Sheltered by the enclosure is a heavy steel door in the eastern wall. This door leads to a small room within the 10-foot-wide wall of the structure. Beyond this room is a corridor, off of which open four vaults. Each vault is 10 feet wide and nearly 13 feet long. The vaults are fitted with shelving for the storage of weapon-related items. The interior plan of this building is identical to that of Building 272.

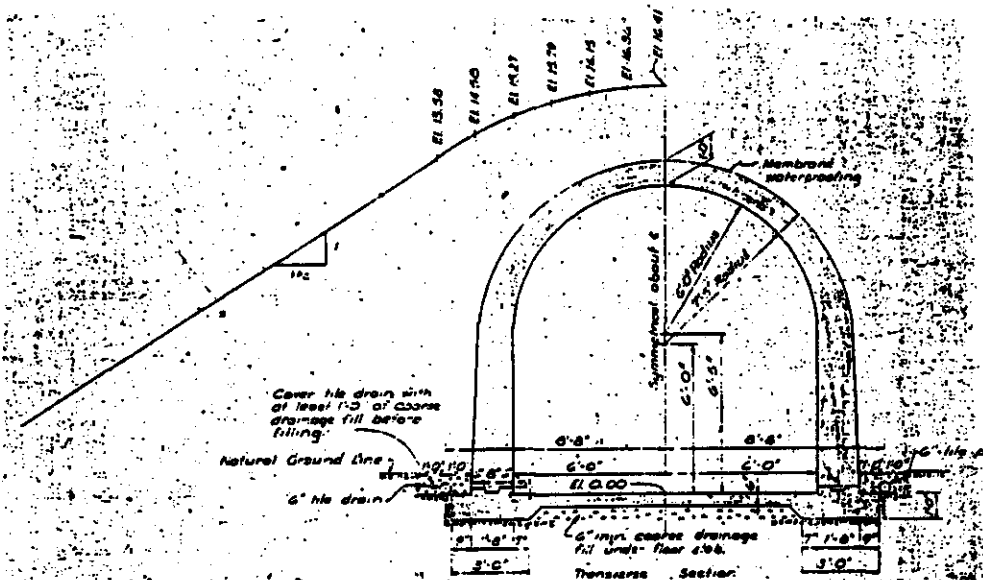
Plan and Section of an Arched Concrete Storage Igloo
 Original drawing at AFBCA, Loring AFB, Maine

The majority of buildings within the Weapons Storage Area are storage igloos, which are reinforced concrete structures designed for the maximum-security storage of weapons, ammunition, and related items. Constructed between 1952 and 1954, the storage igloos at Loring AFB are of three sizes. The majority of igloos (27 of 47) are 29 feet 2 inches by 82 feet 11 inches. Sixteen igloos are 83 feet 7 inches by 30 feet 6 inches. The remaining four igloos are 26 feet 5 inches by 15 feet 4 inches (255, 284, 309, 329). All igloos are earth-covered vaulted structures of reinforced concrete throughout.

Extending from an access road in front of each igloo is a paved unloading area. The facade of the igloo at this location is a broad, nearly triangular form. Centered within the facade is an entrance composed of a pair of heavy steel swing doors. A variety of mechanical and security equipment is mounted on the facade. The sloping sides of the facade project beyond the vaulted concrete walls. The exterior surface of the vault is earth-covered. Intake vents, exhaust vents, and lightning rods extend from the crown of the arch at the exterior.

The igloo interior is a bare, unimpeded, vaulted concrete space. Lights and security equipment have been installed along the crown of the arch. Mechanical equipment has been installed on the wall at the entrance end of the igloo.

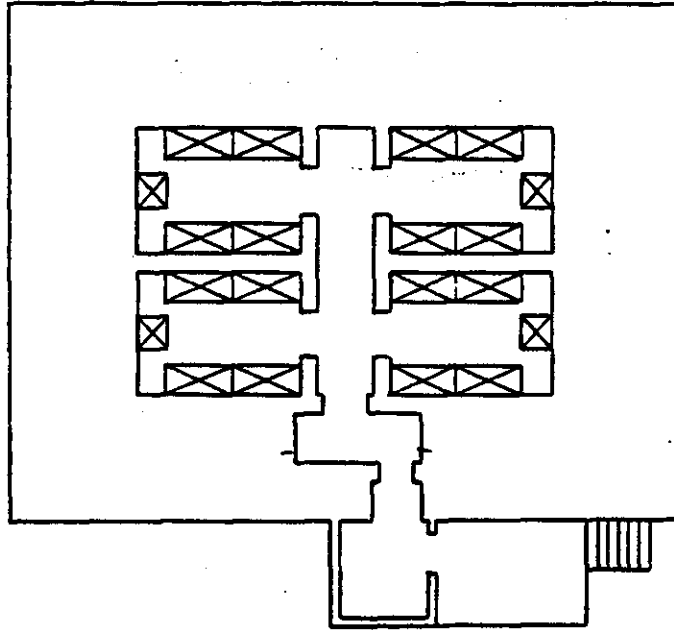
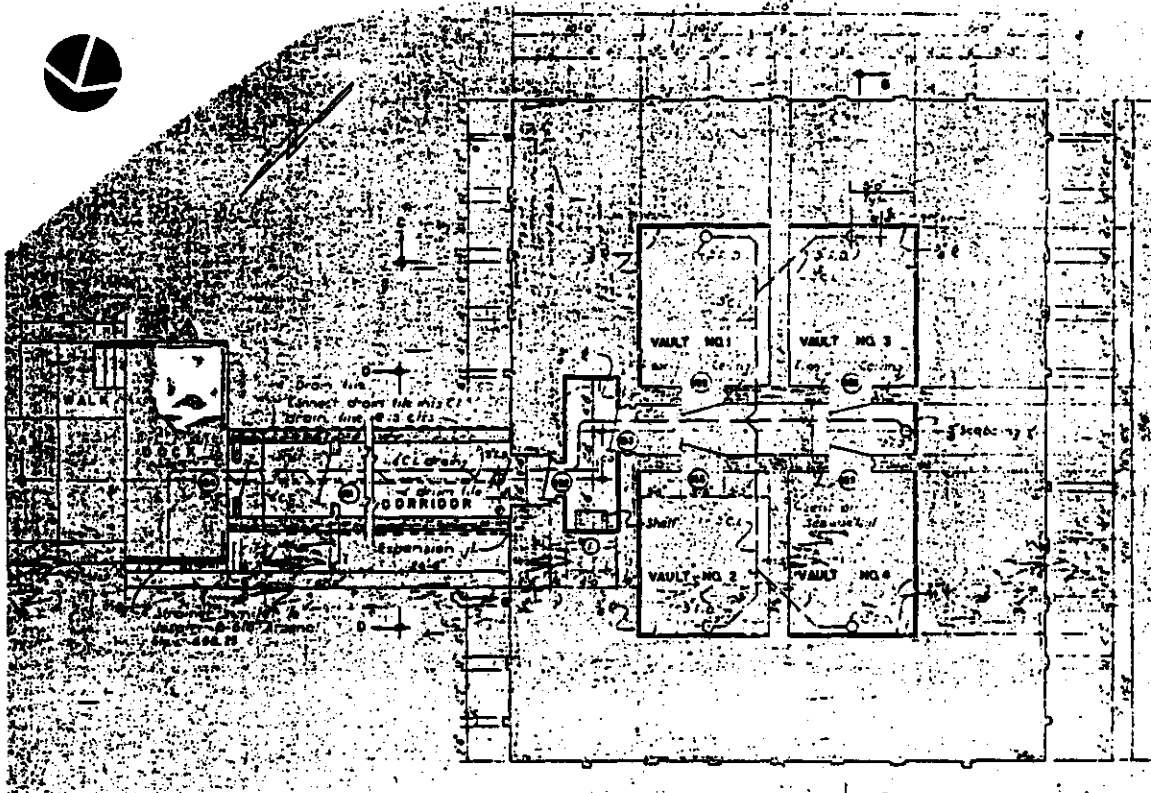
Layout plans of Buildings 260 and 272

Building 272. Building 272, also known as Storage Structure A-2, was constructed in 1955 of reinforced concrete and is similar to Building 260. The structure appears to have a single story above a basement level, but the above-ground level was never a usable space. Its interior cannot be accessed and its apparent window and door openings were never operable. The eastern elevation of the false structure has a blind doorway placed off-center and blind windows flanking the doorway. Each of the other above-ground elevations has blind windows as well.

A basement-level entrance is provided on the eastern elevation. A short concrete stairway leads to a concrete dock with a flat roof. A single doorway provides access to the 34-foot-long corridor that leads to a small room contained within the exterior wall of the building. Beyond this room, the interior is identical to that of Building 260.

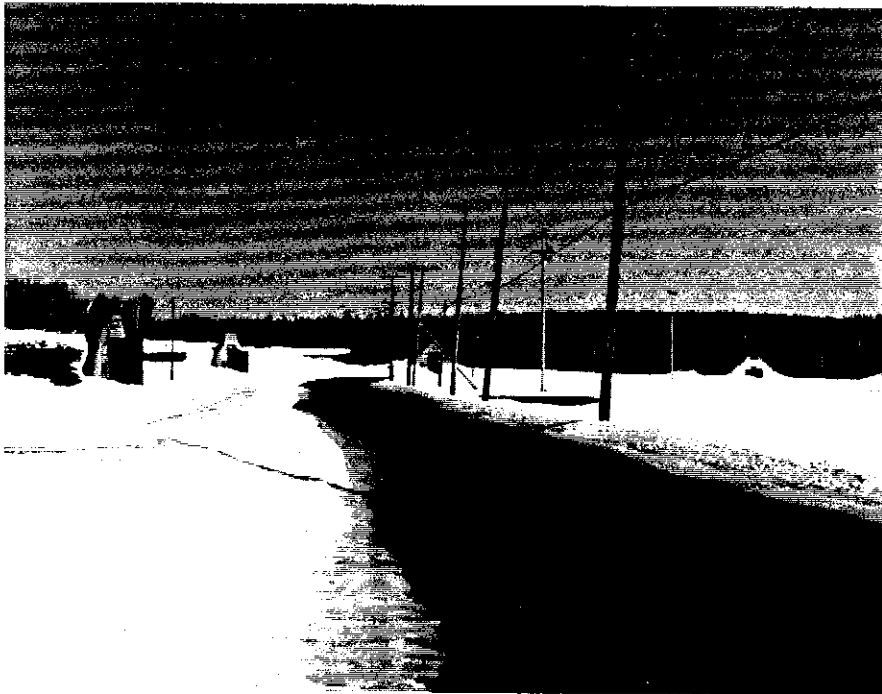
View of Buildings 280, 281, 282, and 284 along Service Road A, looking northeast.

Photograph date: February 1994. Photograph location: AFBCA, Loring AFB, Maine.
