NEW YORK STATE BARGE CANAL, LOCK E5
(Erie Canal, Lock E5)
55 Flightlock Road
Waterford
Saratoga County
New York

WRITTEN HISTORICAL AND DESCRIPTIVE DATA

HAER No. NY-376

Appendix: Images of Current Conditions

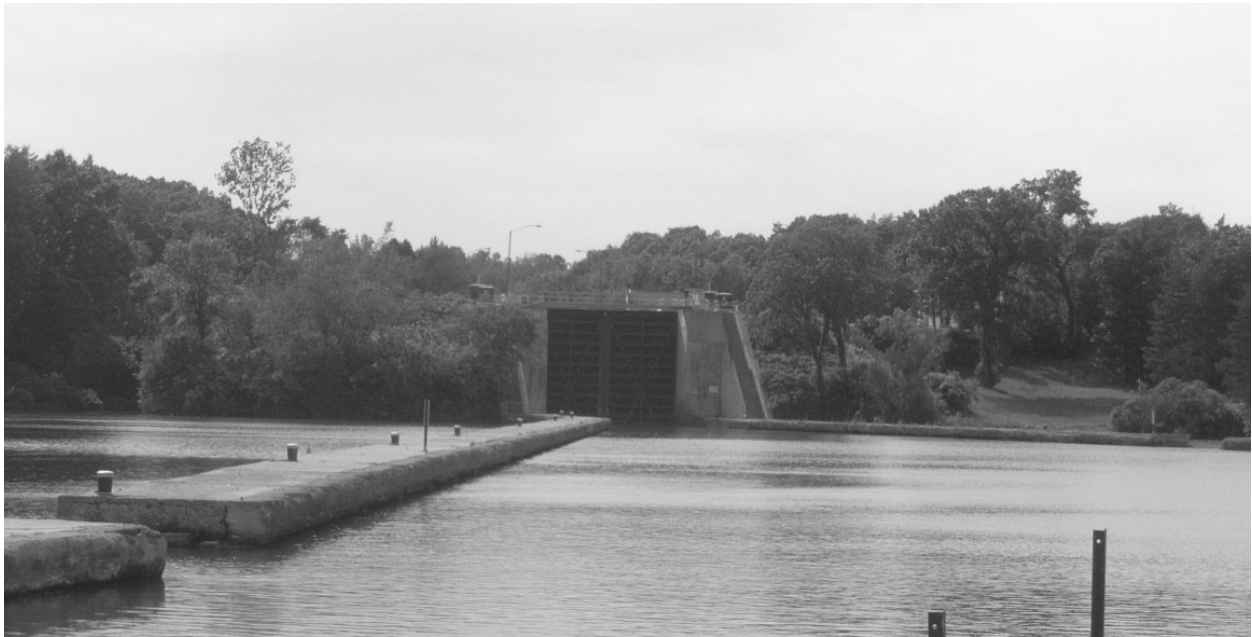
Image 1: Downstream approach to Lock E5. Field photograph taken by HAER recording team, summer 2009.

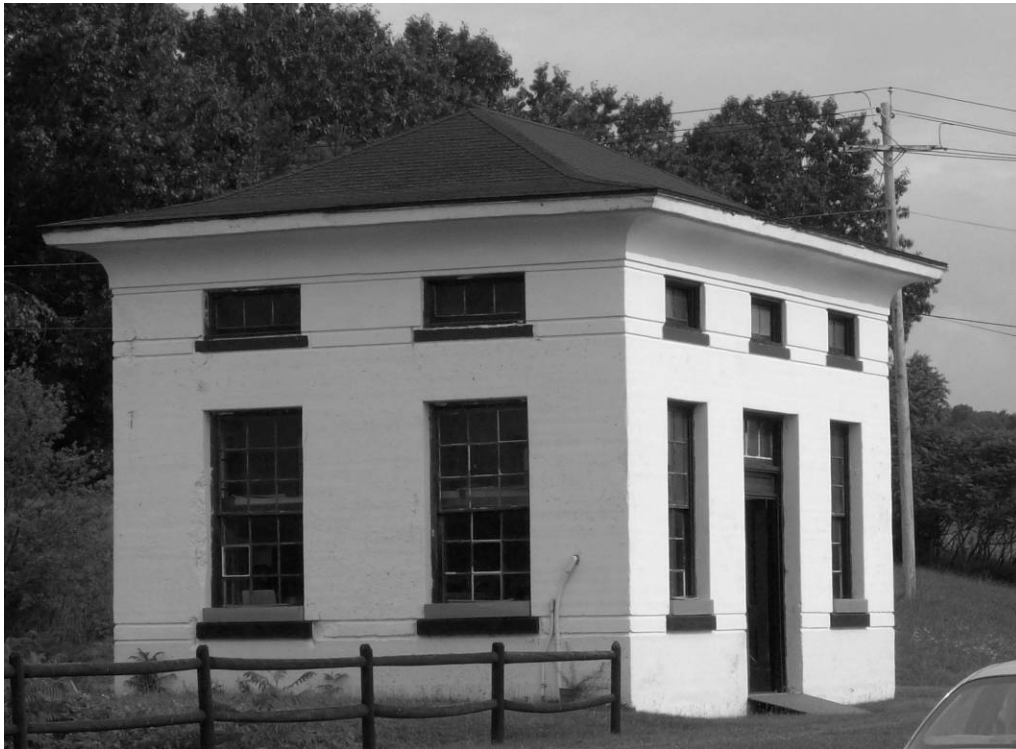
The powerhouse, located just off Flightlock Road to the north of the chamber, is a single-story concrete building with a hipped asphalt-covered roof. Wood entry doors with four-light transom windows provide access to the building. The fenestration consists of nine-over-nine-light wood windows with three-light windows in the eaves. The original motor-generator sets have been removed from the building, and an office now occupies the space. The bridge crane, however, is still extant. The powerhouse is in fair condition due to the poor condition of the roof and spalling concrete.

Image 2: Powerhouse. Field photograph taken by HAER recording team, summer 2009.

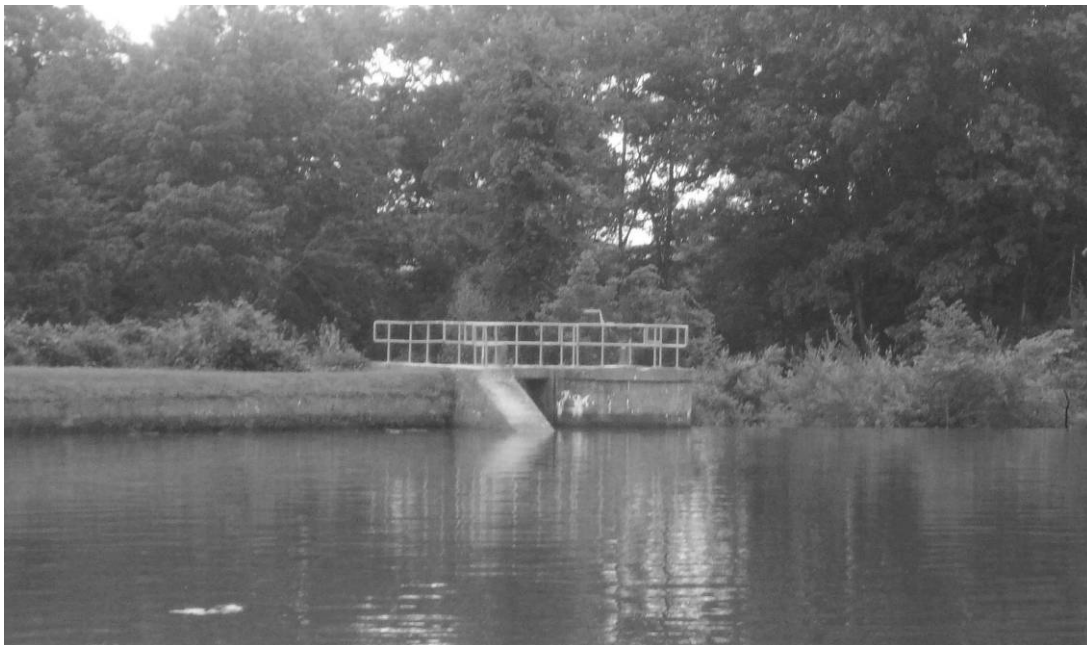
An earthen embankment with a concrete core forms a large pool between locks E5 and E6. There is a bypass channel paralleling the lock to the south, which is equipped with a concrete spillway at the west end. The stop-log section is built of welded steel and rubber with a valve at the end. The concrete platform has a pipe railing. The bypass and spillway empty into a natural bedrock channel. The spillway is in fair condition due to deteriorating concrete.

Image 3: Stop-log section of the spillway. Field photograph taken by HAER recording team, summer 2009.
