NEW YORK STATE BARGE CANAL, LOCK E6
(Erie Canal, Lock E6)
77 Flightlock Road
Waterford
Saratoga County
New York

WRITTEN HISTORICAL AND DESCRIPTIVE DATA

HISTORIC AMERICAN ENGINEERING RECORD

HAER No. NY-377

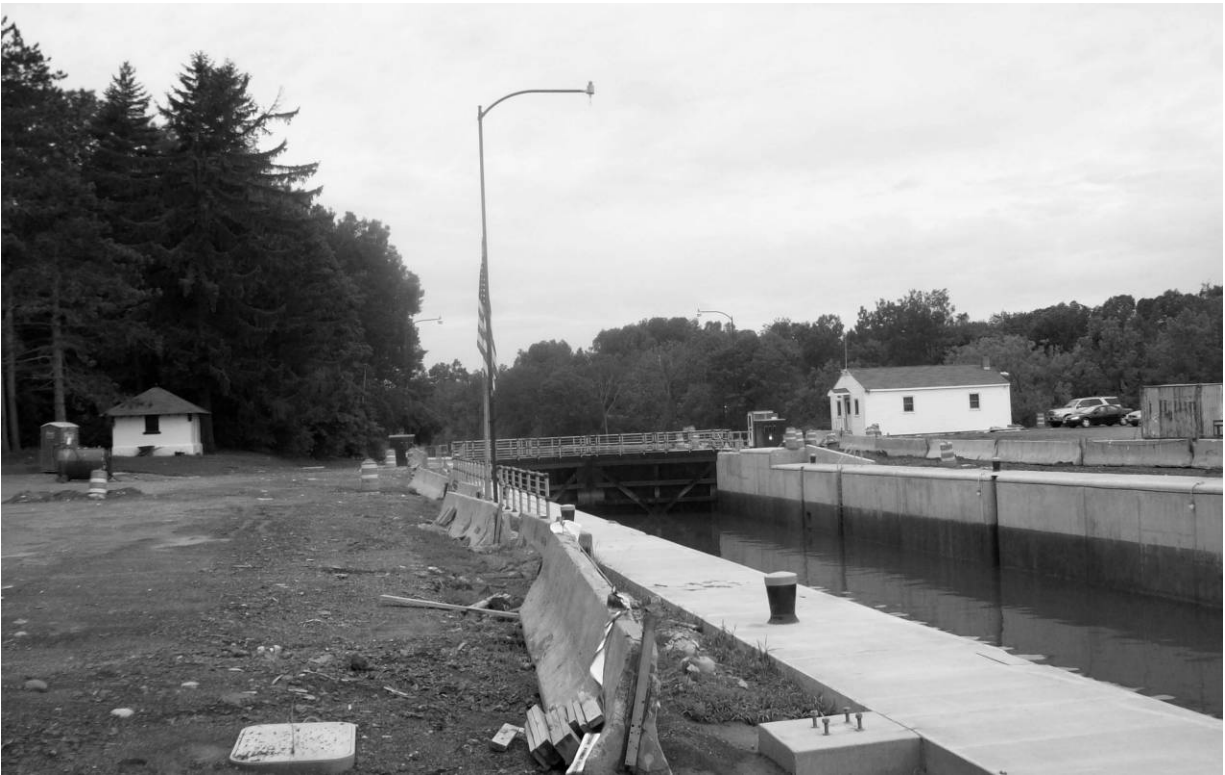
Image 1: Overview of lock with storehouse to left of chamber and lockhouse to right. Field photograph taken by HAER recording team, summer 2009.

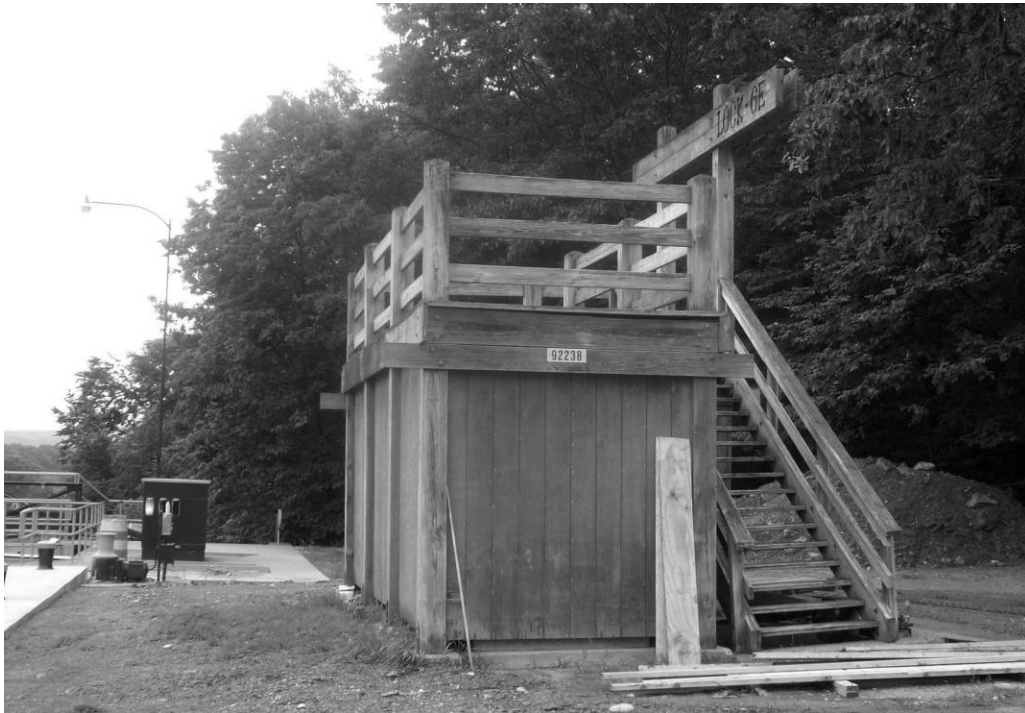
Image 2: Observation deck. Field photograph taken by HAER recording team, summer 2009.

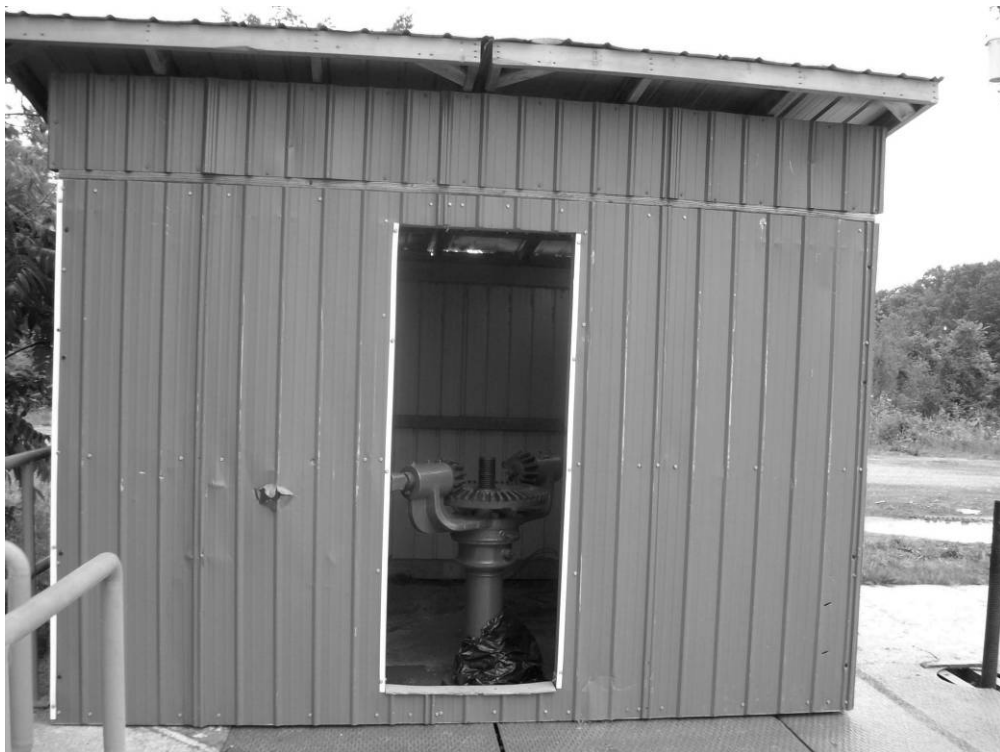
A bypass channel parallels the lock to the north. A two-span sluice gate is located at the west end of the channel, just off the access road to the lock. The sluice gate is equipped with a valve gear mechanism sheltered by a structure clad in steel sheeting. There is a concrete platform with a pipe railing as well. The sluice gate is in good condition.

Image 3: Shelter over sluice gate valve. Field photograph taken by HAER recording team, summer 2009.
