U.S. Army Depot Activity, Umatilla
(Umatilla Army Depot)
Hermiston
Umatilla County
Oregon

HAER No. OR-5

WRITTEN HISTORICAL AND DESCRIPTIVE DATA

U.S. Army Depot Activity, Umatilla

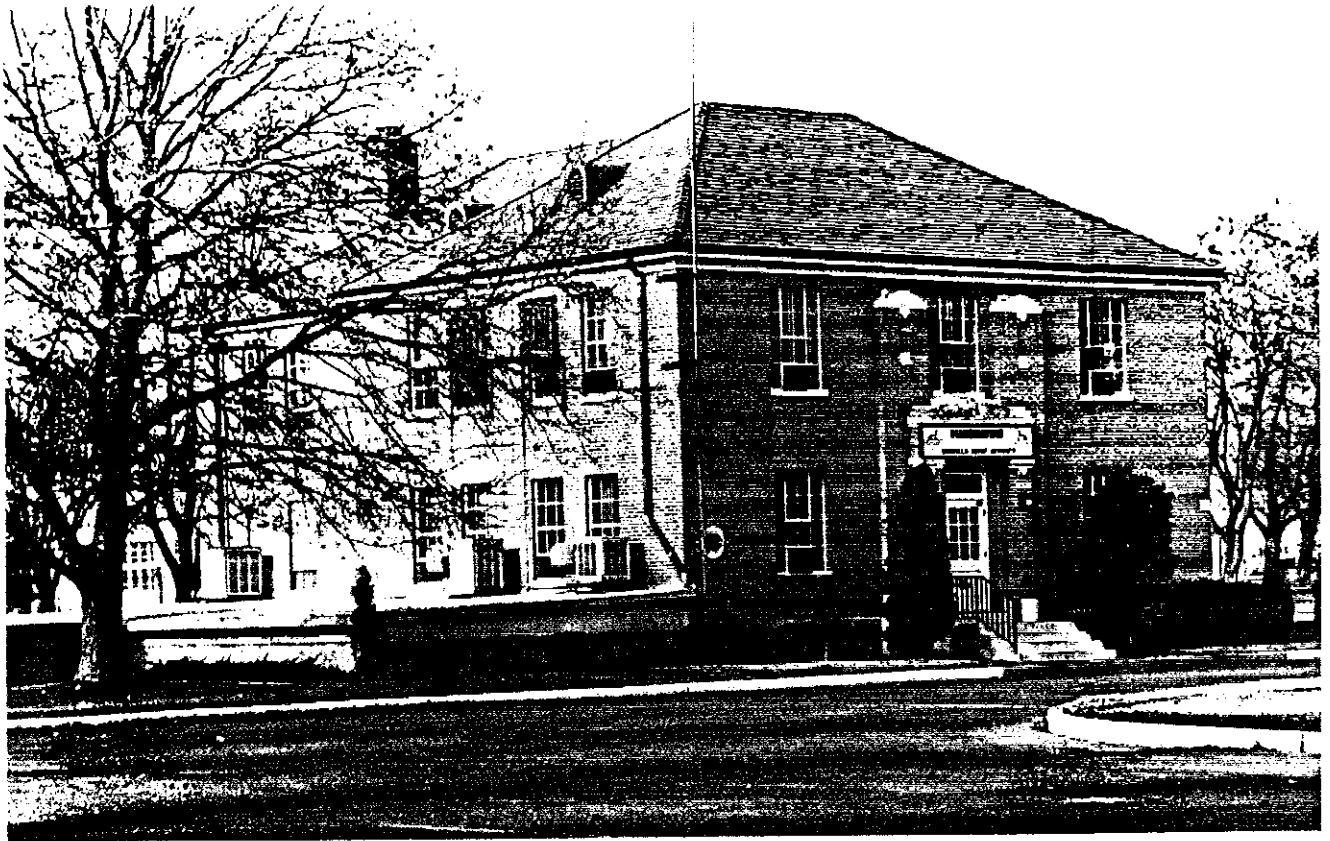
Illustration 2 View of the east and south sides of Building 1. The headquarters building, a two-story brick structure with red clay tile hip roofs, is one of the most architecturally distinctive buildings on the installation. The use of permanent masonry construction for key buildings in the administration area is a characteristic feature of ammunition supply depots constructed before the spring of 1942, when masonry materials became in short supply. (Source: Field inventory photograph, 1984, Barbara Hightower, Building Technology, Inc.)

faces the parade ground. Other brick structures erected in the administration area in 1941 are a gate guardhouse (Building 3), a family quarters garage (Building 70), two inert storage warehouses (Buildings 17 and 18), a machine shop (Building 4), a garage (Building 5), a motor fuel station (Building 6), a carpenter shop (Building 7), a paint shop (Building 8), a paint storage building (Building 9), and a railroad engine house (Building 10). Most are one-story, gable-roofed structures.⁶ (Illustration 2)

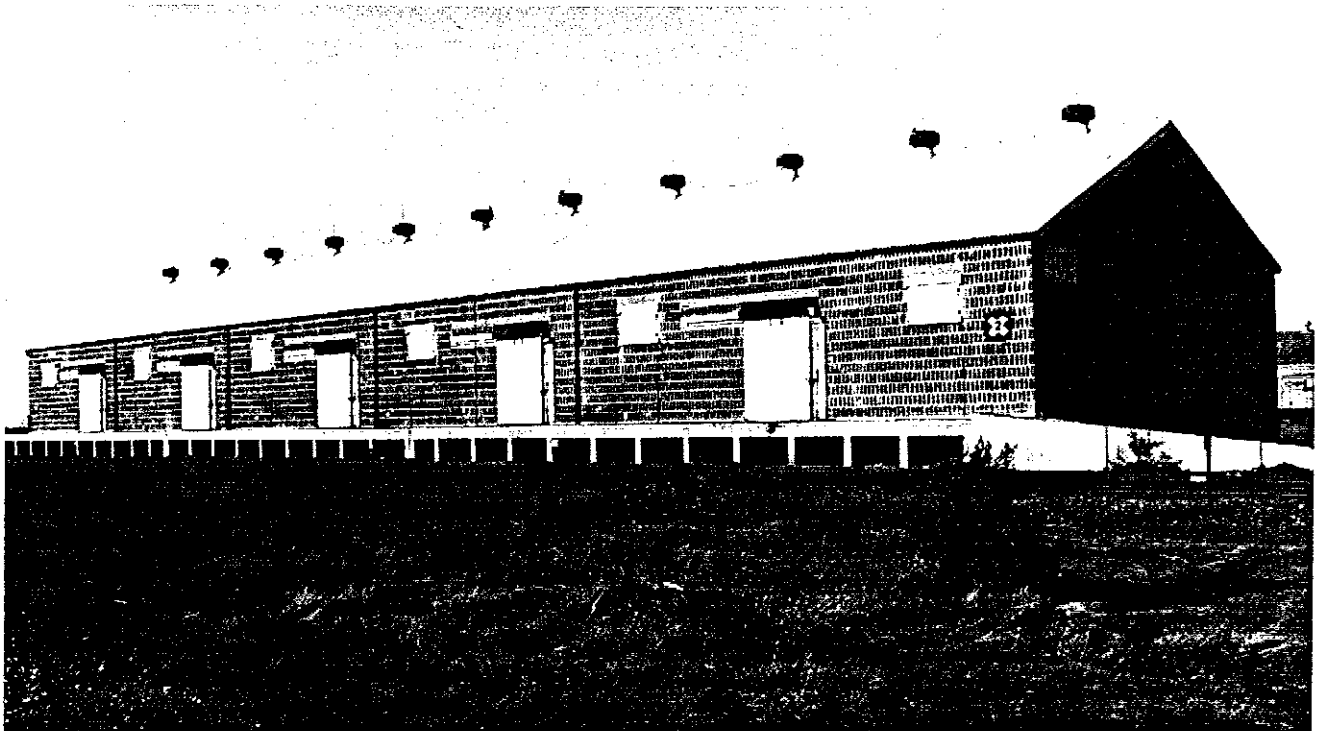
Illustration 4 View of the south side of Building 402. Fourteen standard above-ground ammunition magazines with 8-inch clay tile walls were built at the south end of the ammunition storage area in 1941. Each has a raised concrete platform lined with sliding metal doors on the side serviced by rail lines. (Source: Field inventory photograph, 1984, Barbara Hightower, Building Technology, Inc.)

Fourteen standard above-ground ammunition magazines (Buildings 401-414) were erected at the south end of the ammunition storage area in 1941. Each is constructed with 8-inch clay tile walls on reinforced concrete foundations and has a gable roof of corrugated asbestos supported by steel Fink trusses; five sliding metal doors line concrete platforms on the side of the building serviced by rail lines. (Illustration 4)
