DREIBELBIS STATION BRIDGE
National Covered Bridges Recording Project
Spanning Maiden Creek, Balthaser Road (TR 745)
Lenhartsville vicinity
Berks County
Pennsylvania

HAER PA-587
PA-587

DREIBELBIS STATION BRIDGE

STRUCTURAL TYPE: Wooden covered bridge, Burr arch-truss

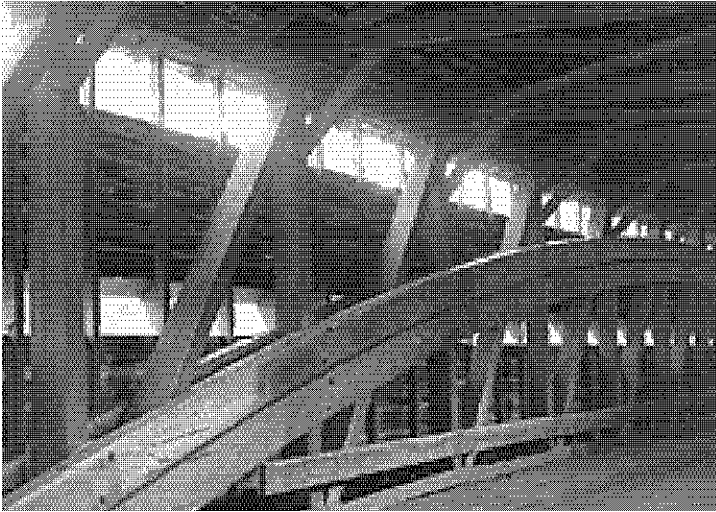
Illustration 1: South truss.
Field photo courtesy of author.

The Dreibelbis Station Bridge is composed of a 172' Burr arch and a sixteen-panel multiple kingpost truss (see Appendix A, Illustration 1).¹ The panels are each 10.5' wide (see Appendix A, Illustration 2). The bridge is probably built of local white pine, the favored lumber in the region.² The bridge is warped, bowed longitudinally. The top chord on the upstream side uses five members to make the length of the bridge. On the downstream truss, four members make up the top chord. These are joined with a tension splice and bolt assembly. Some also have a shear key. The chord members are 10" square. The laminated bottom chords are composed of two 8" x 14" timbers joined with bolts at each post and by the floor beams, which are notched to sandwich the chord members together and act as tie beams connecting the lower chord on each side.

The arches are paired, with two sets of concentric arches on each truss side (see Appendix A, Illustration 1). The arch timbers are 6" thick and 14" wide, making for a sturdy looking structure. There are five timber segments to each arch. These are secured with a lap joint and bolt assembly through the posts. The segments of the upper arches are never spliced at the same post as are the segments of the lower arch. In the last two truss panels on each end, wooden spacers force the arches to flare away from the posts

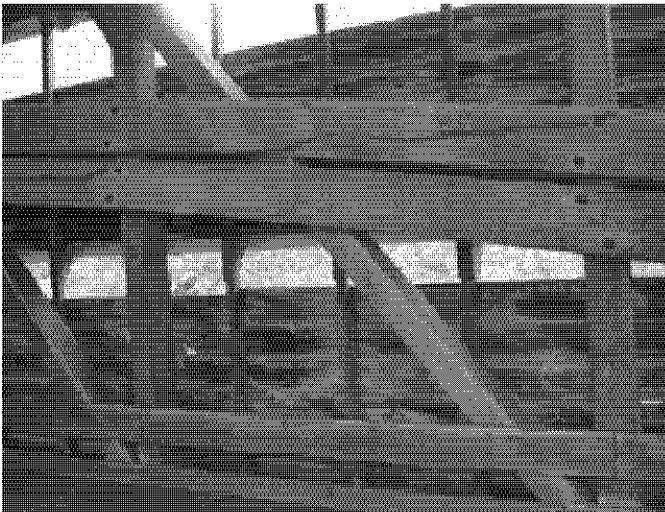
Illustration 2: A single truss panel. Field photo courtesy of author.

the required distance to sandwich the lower chord. Otherwise, the arches meet the posts directly and are bolted to them with staggered bolts, two on each arch (see Appendix A, Illustration 2).

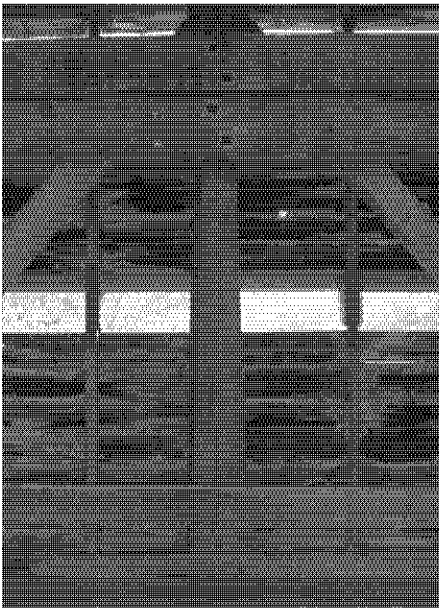
Illustration 3: Center kingpost. Field photo courtesy of author.

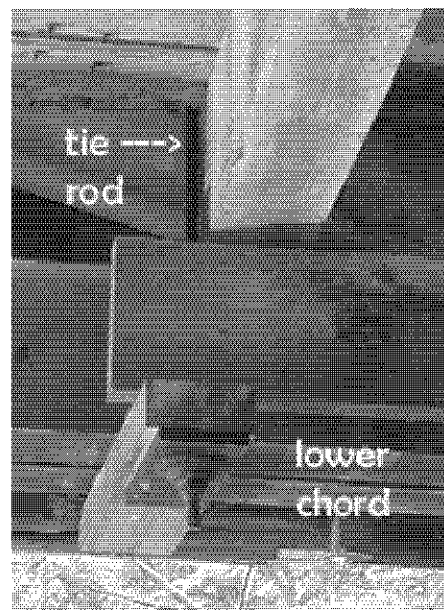
Illustration 6: Tie rod at the lower chord. Field photo courtesy of author.

At the point where the arches meet the deck, they are tied with iron rods to the bottom chord (see Appendix A, Illustrations 5 and 6).³ A metal plate and bolt assembly attaches the rod to the arch. Underneath the bridge, the rod is put in tension with a two-by-four placed against the bottom of the lower chord and the bottom of a plank below the adjacent floor beam. The threaded end of the rod allows the tension to be adjusted with a nut.

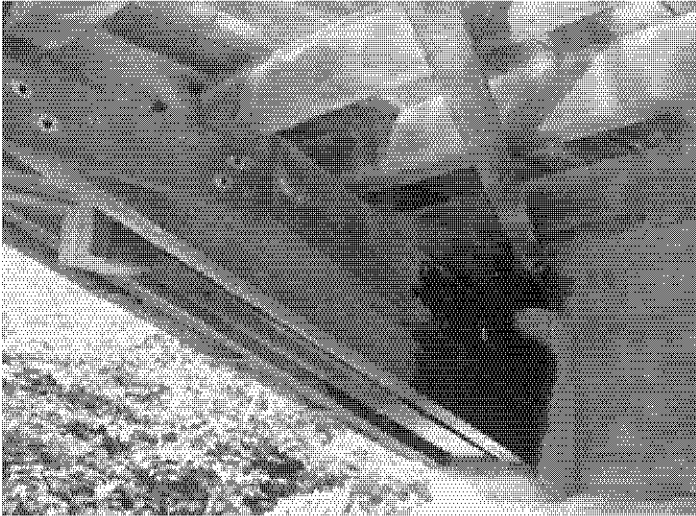
Illustration 7: The arches at the east abutment. Field photo courtesy of author.

At the abutments, the arches butt against a concrete slab added to the structure in 1968 (see Appendix A, Illustrations 7 and 8).⁴ At that time, the county had the arch ends replaced where they were rotting against the rock face. The restoration at that time changed the abutment face to concrete and reinforced the arches with additional wood members between the arches.

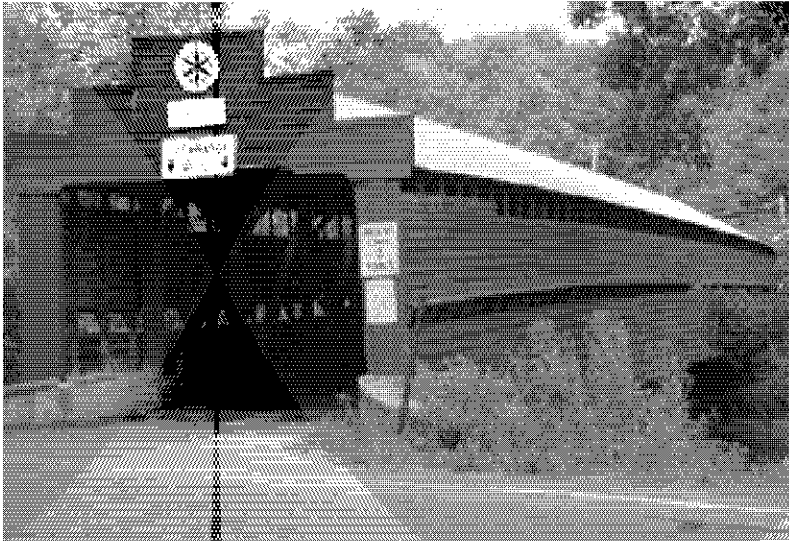
Illustration 9: West portal.
Field photo courtesy of
author.

A stepped false front over the gable end, which is a regional convention, decorates the portal faces (see Appendix A, Illustration 9). The false front employs horizontal planks, while vertical planks form the portal's sides. All of this is painted red. Each portal has four signs attached. In the tympanum there is a name plaque, a hex sign, and a height limit.⁷ On the right side of each portal is a weight limit sign. The vertical clearance is 12', and the opening is 16'-5" wide. Cut stone wing walls at each entrance are enveloped in concrete.⁸ They also have a concrete cap that predates the 1968 restoration of the abutments.
