Farmer-Stockman

Rangeland Miracle

By JERRY LESTER

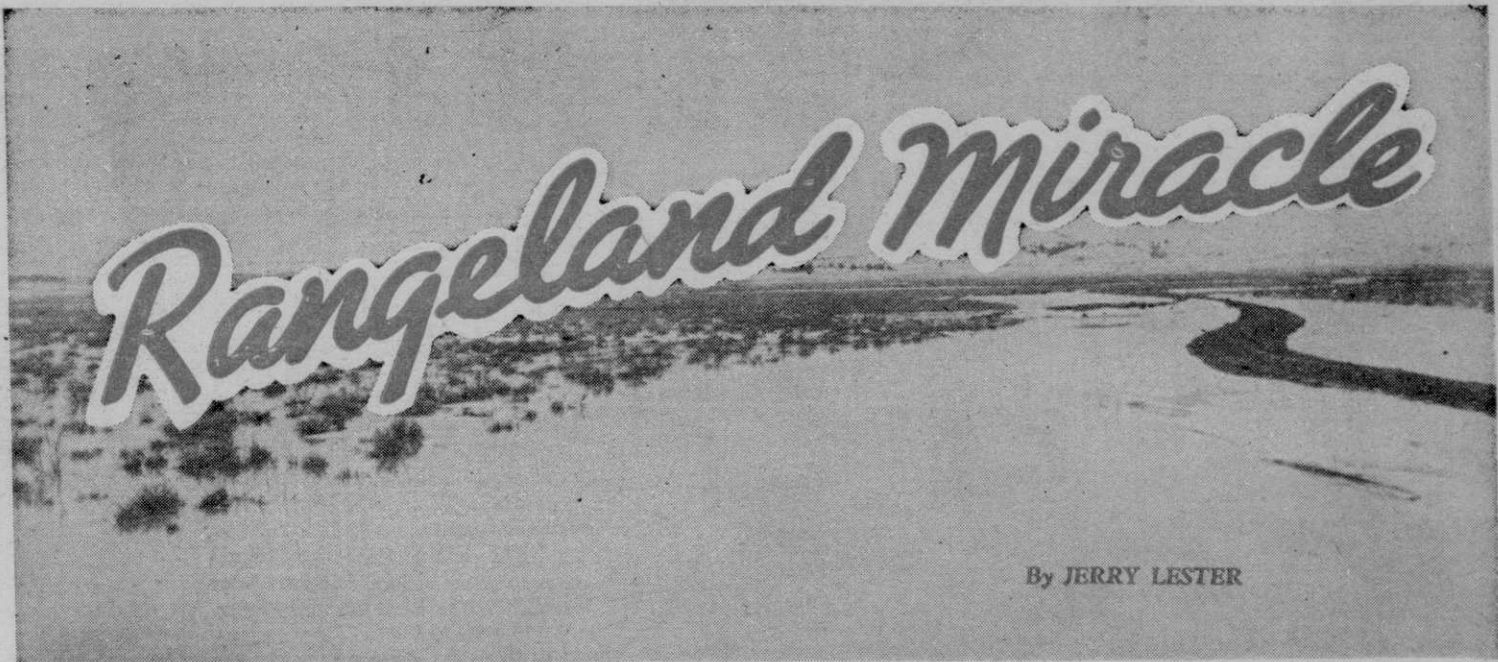
Here is the first spring run-off caught on the redesigned dike system of the Alzada project in Carter county. Snow still remains along the sides of the dike to the right while the excellent job of water spreading can be seen to the left through the sage brush. Such irrigation increased carrying capacity by 350 percent

According to Tom Dudley, range manager, bureau of land management, Miles City, the secret of increasing forage on this type of land lies in spreading the water (mostly spring run-off and heavy flood waters from rains) over the range with a system of dikes that will hold the water for a time but also allow it to flow around and flood lower diked areas.

The work was started in 1945 and followed along the usual lines considered common practice in the area. The dikes were laid out herringbone style, following the practice of most ranchers in the area, who diked across the cuts in a manner that allows the water to spread but also flow down the slope of the land. The slope here, incidentally, was from $\frac{1}{2}$ to $1\frac{1}{2}$ percent.

The next year, the dikes were put in on the contour of the land. Stakes were placed to mark the position of the dikes and then a two pronged ripper was used to rip up the hard pan as deep as possible. Then a bull dozer or motor patrol was used to build up the 3 foot high dikes. Toward the upper end of the system or in the lower places, wherever it was assumed a considerable amount of silt would settle, the

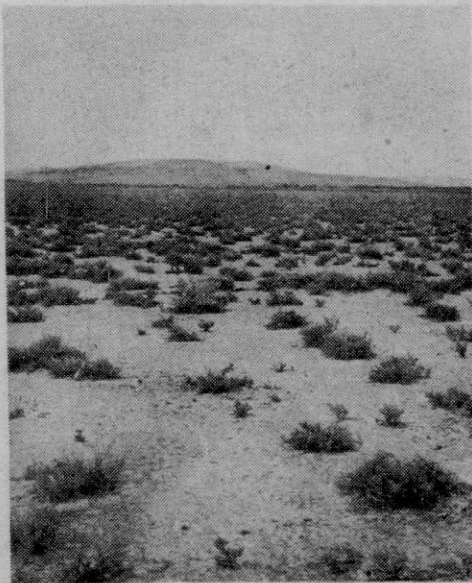
Before

Here is the gumbo hardpan sage land with sun-baked cracks before the water project was started.

The project involved 1,000 acres of gumbo land, much of which was cut up with deep gullies and washed-out draws. The area was one of baked, hardpan soil with sage brush and very little range grass. Surrounding hills formed a considerable drainage basin,

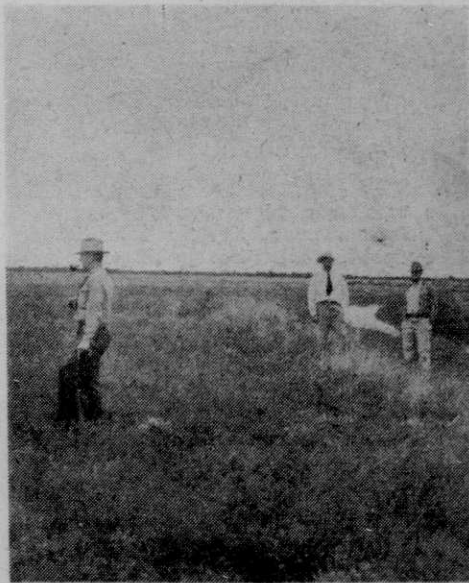
After

Here is the result of the water spreading seen two years later—a good stand of native range grass where only sage brush and a few straggling blades of grass stood before. The men in the picture are, left to right: Leon Huret, forest supervisor, Rocky Mountain experiment station, Missoula; Larry Short, chief of range research, range experiment station, Miles City, and Tom Dudley, range manager, bureau of land management, Miles City.

Prior to construction, the 1,000 acres of land were given an animal carrying capacity of 10 head but three years later this was raised to 35 head, an increase of $3\frac{1}{2}$ times. The cost of development was about \$3 an acre.
