ADDENDUM TO:  
ST. ELIZABETHS HOSPITAL, L BUILDING  
(Building No. 64)  
2700 Martin Luther King Jr. Avenue, Southeast  
Washington  
District of Columbia

## HISTORIC AMERICAN BUILDINGS SURVEY

### ST. ELIZABETHS HOSPITAL, L BUILDING (BUILDING 64)

ADDENDUM TO  
HABS No. DC-349-F

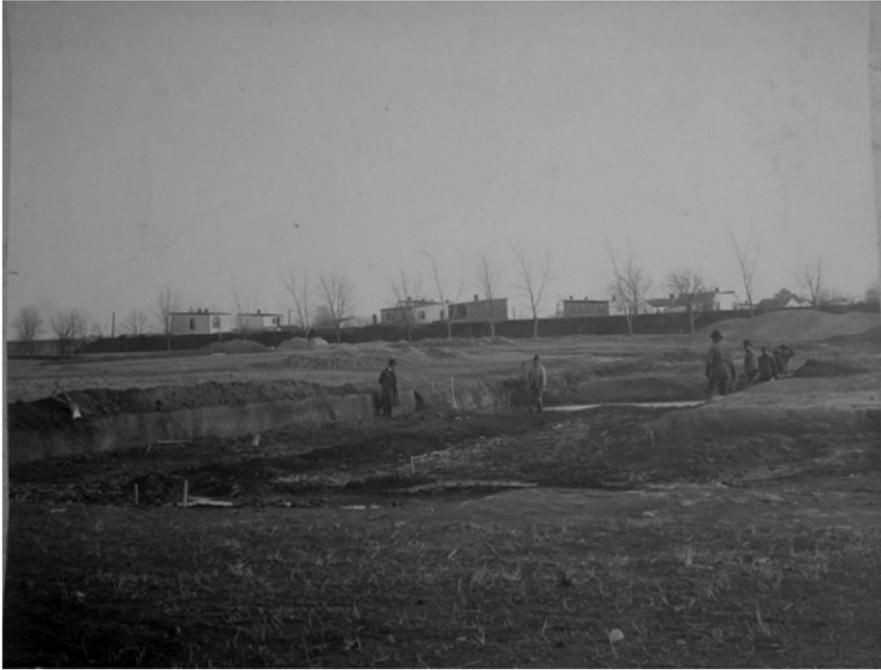
*Figure 1. View of patients digging foundation for lettered building, circa 1901. Source: National Archives at College Park, Maryland. Record Group 48, Entry 300, Box 6.*

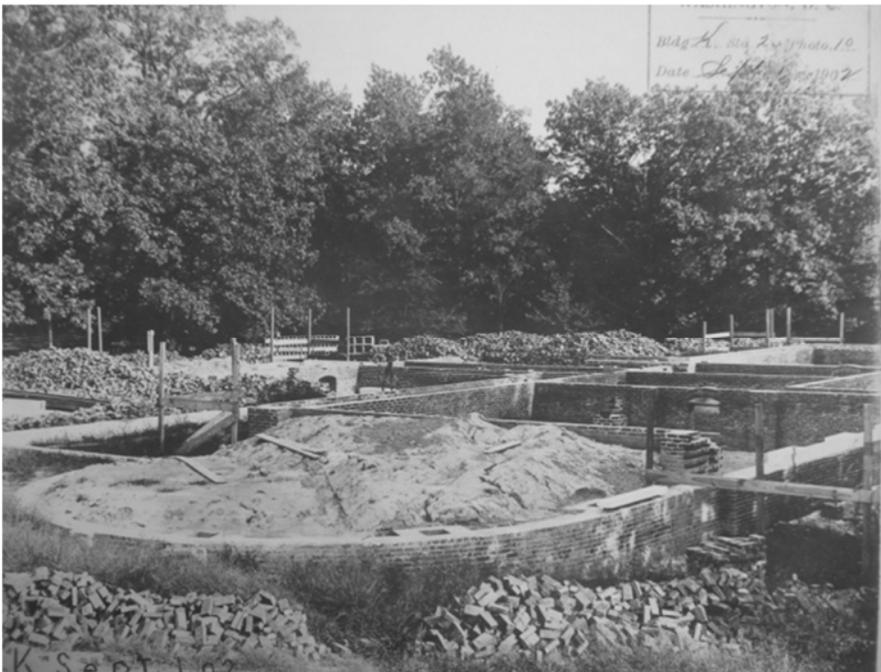
*Figure 2. Foundation walls of K Building as observed on September 1, 1902. Source: National Archives at College Park, Maryland. Record Group 48, Entry 300, Box 6.*

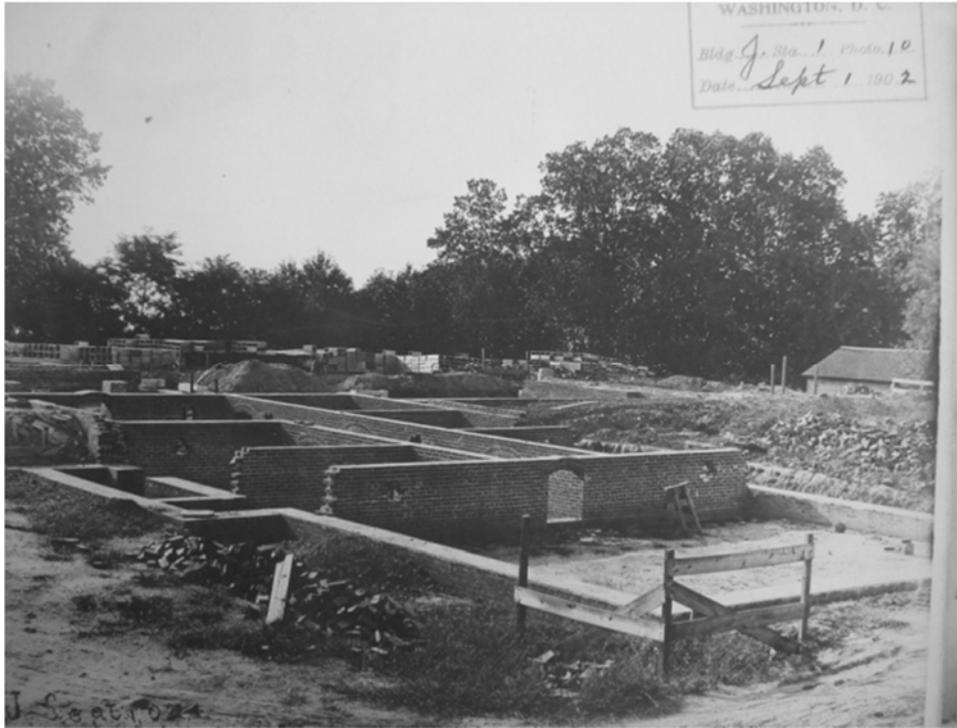
Figure 3. View of brick foundation walls of J Building as observed on September 1, 1902. Source: National Archives at College Park, Maryland. Record Group 48, Entry 300, Box 6.

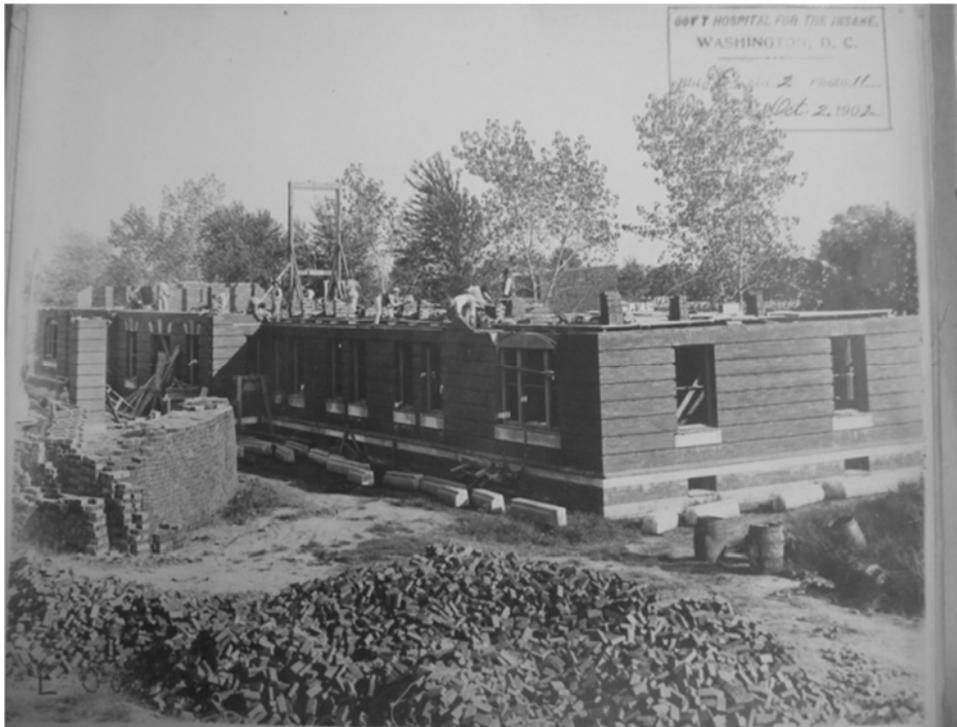
Figure 4. View of B Building construction as observed on October 2, 1902. Note stockpiles of brick and stone in foreground. Source: National Archives at College Park, Maryland. Record Group 48, Entry 300, Box 6.

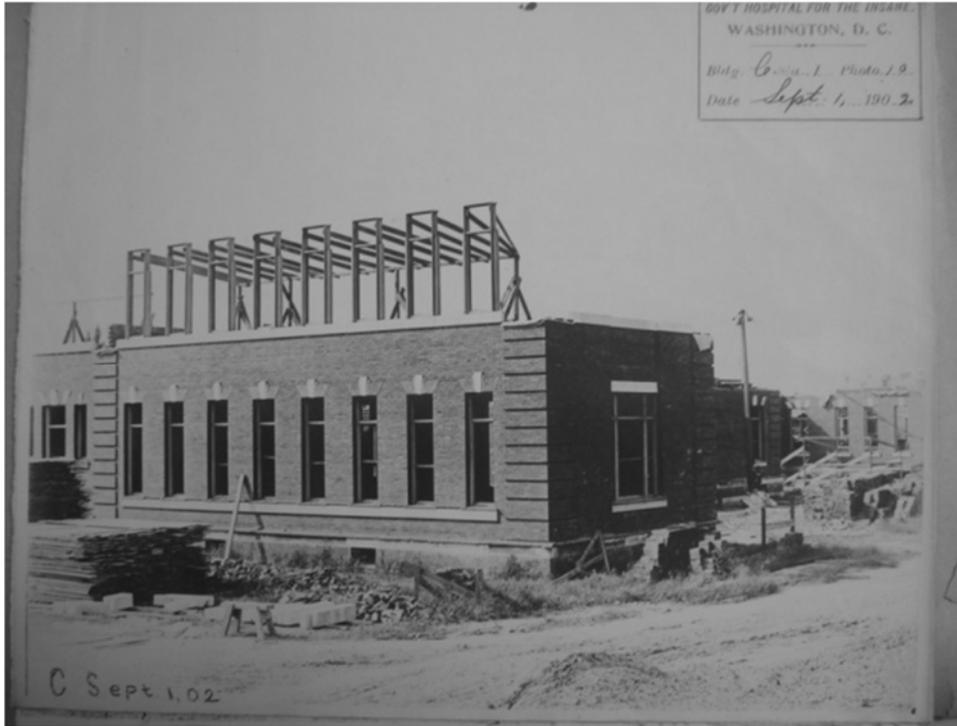
Figure 5. View of second floor wall construction of C Building as observed on September 1, 1902. Source: National Archives at College Park, Maryland. Record Group 48, Entry 300, Box 6.

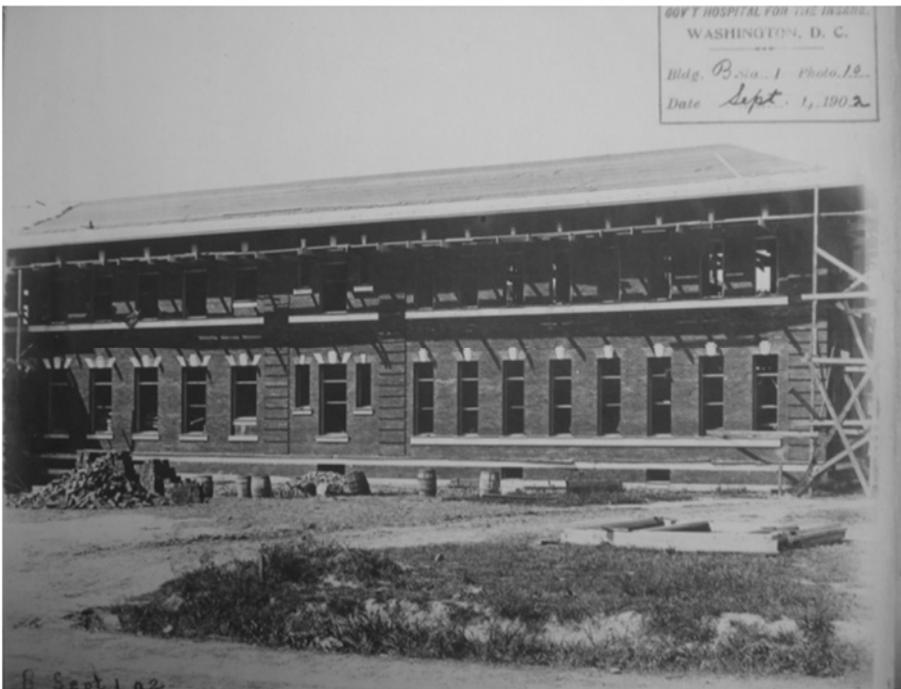
Figure 6. View of B Building nearing complete enclosure as observed on September 1, 1902. Source: National Archives at College Park, Maryland. Record Group 48, Entry 300, Box 6.

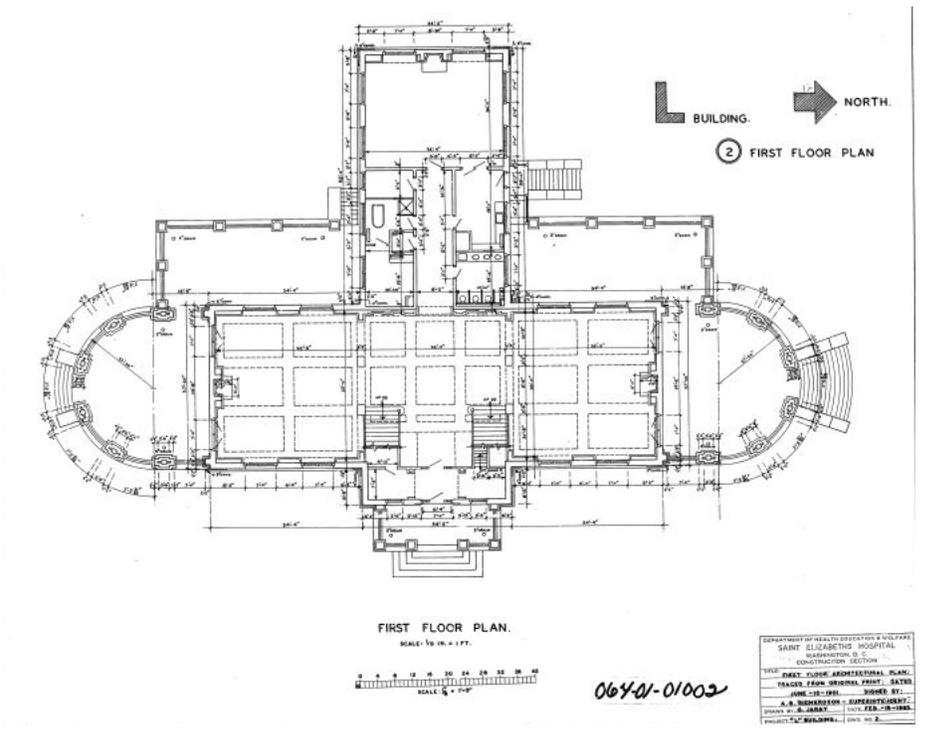
Figure 7. The first floor plan of the L Building as depicted in 1901 construction documents. Source: GSA archives, image DC0107SE0101.

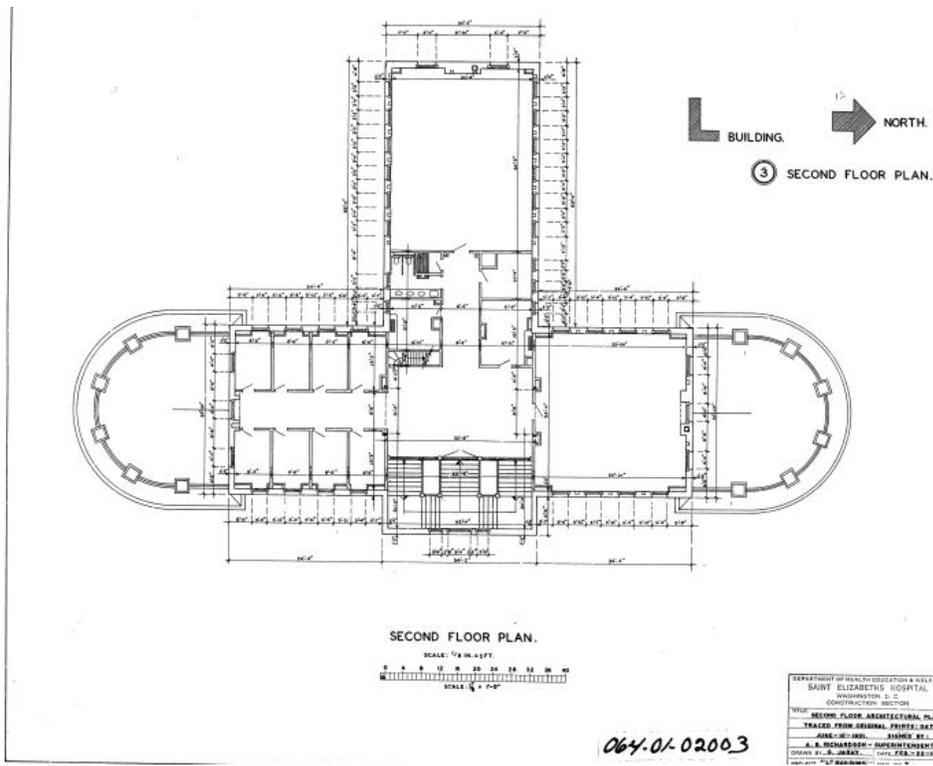
Figure 8. The second floor plan of the L Building as depicted in 1901 construction documents. Source: GSA archives, image DC0107SE0102.

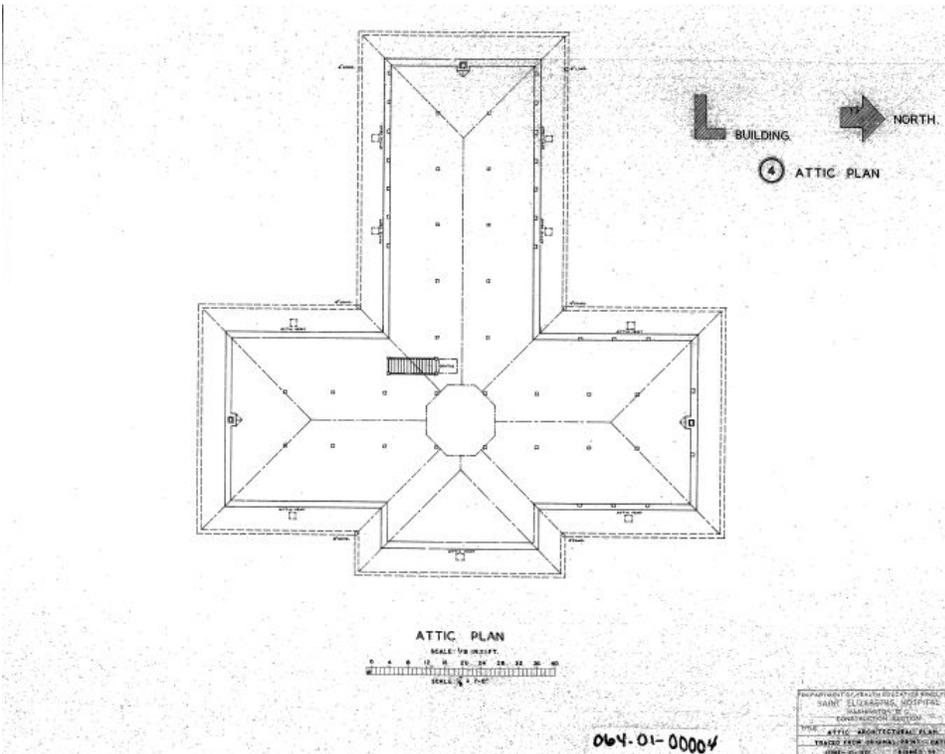
Figure 9. The roof plan of the L Building as depicted in 1901 construction documents. Source: GSA archives, image DC0107SE0103.

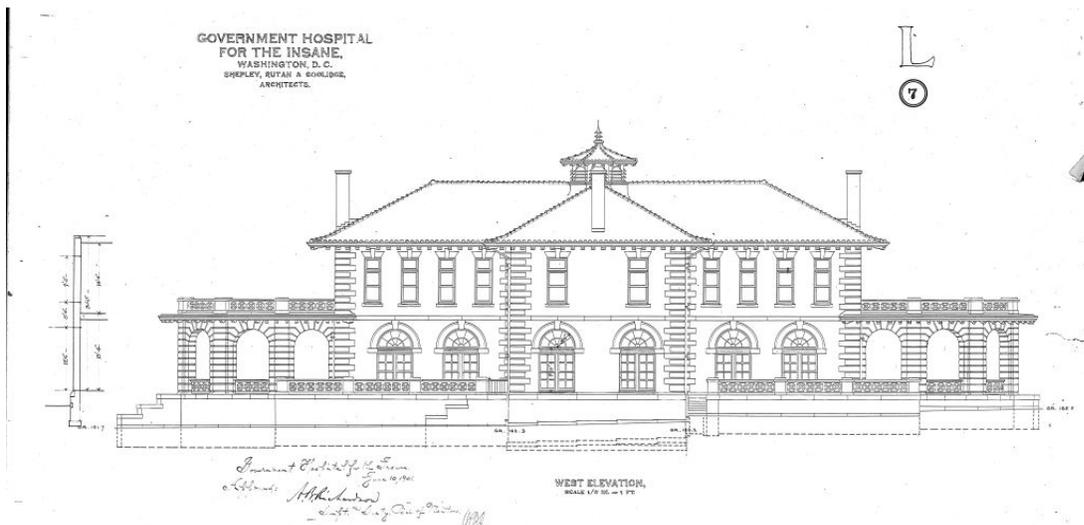
Figure 10. L Building west elevation as depicted in 1901 construction documents. Source: GSA archives, image DC0107SE0127.

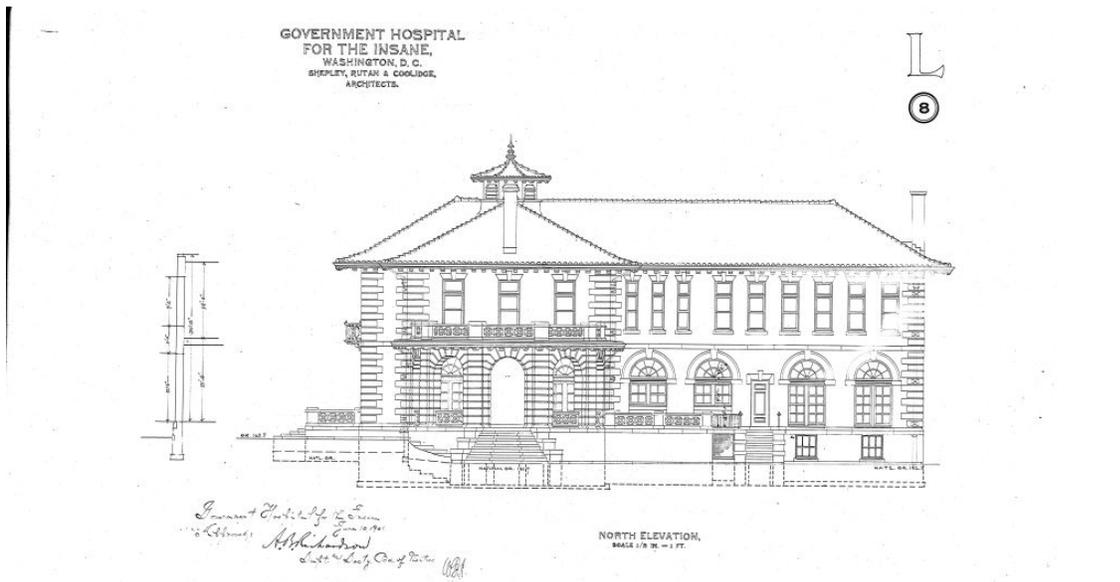
Figure 11. The north elevation as depicted in 1901 construction documents. Source: GSA archives, image DC0107SE0128.

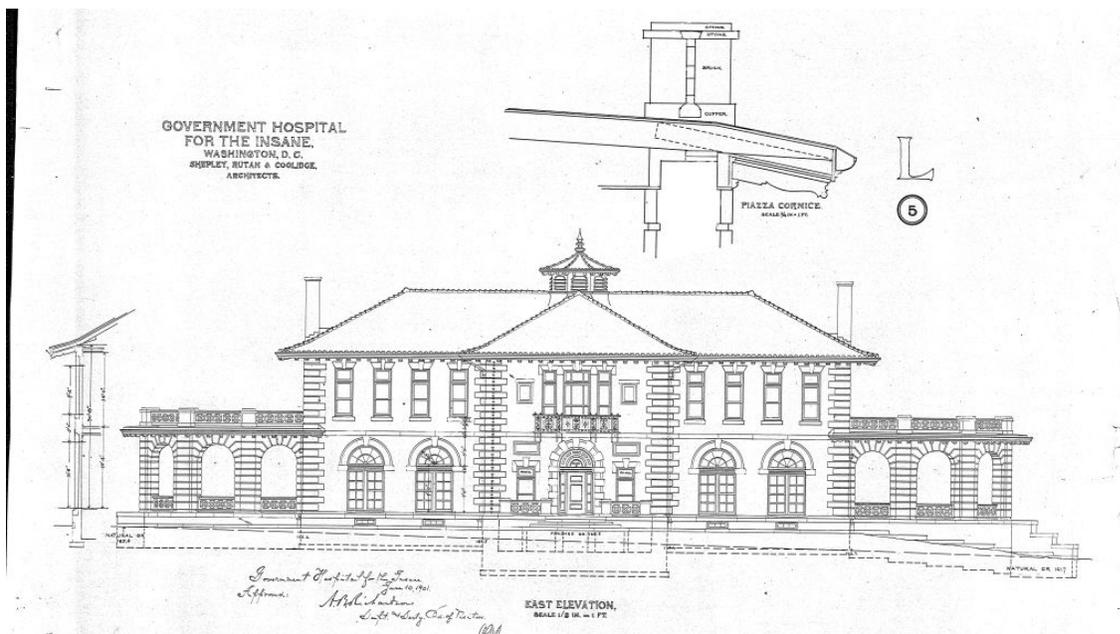
Figure 12. The east elevation as depicted in 1901 construction documents. Source: GSA archives, image DC0107SE0129.

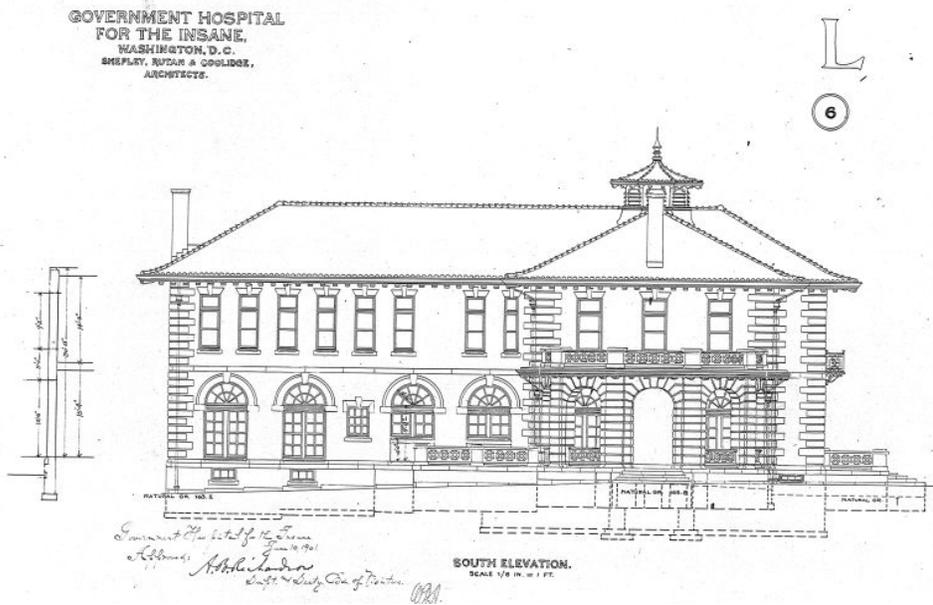
Figure 13. The south elevation as depicted in 1901. Source: GSA archives, image DC0107SE0130.

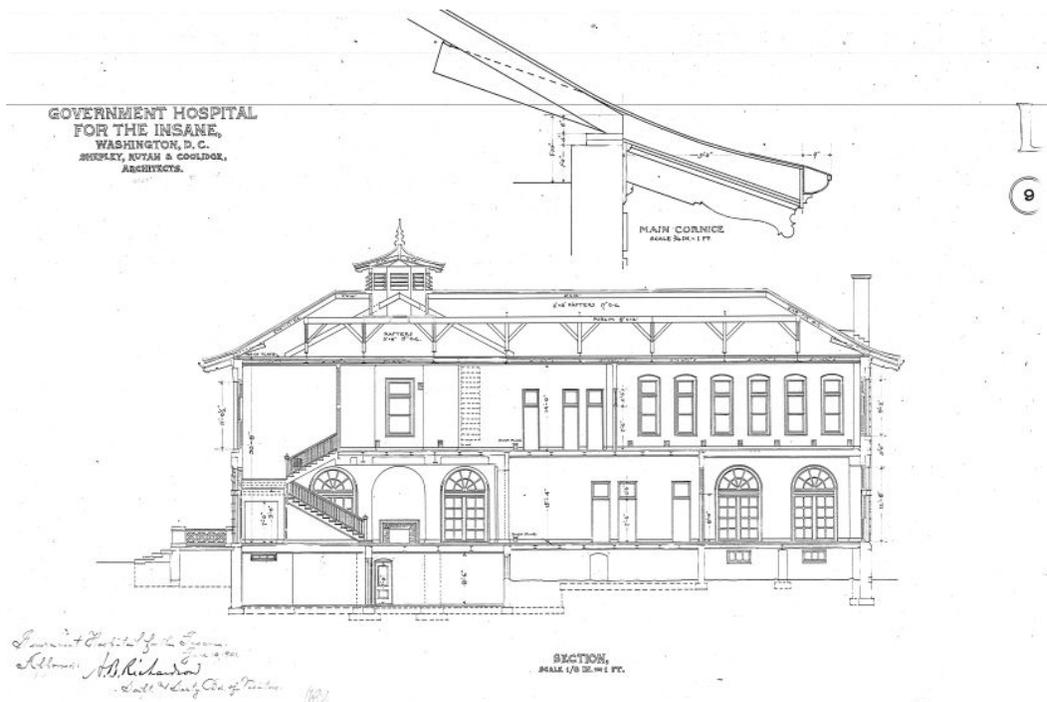
Figure 14. A transverse section of the L Building as depicted in 1901. Source: GSA archives, image DC0107SE0115.

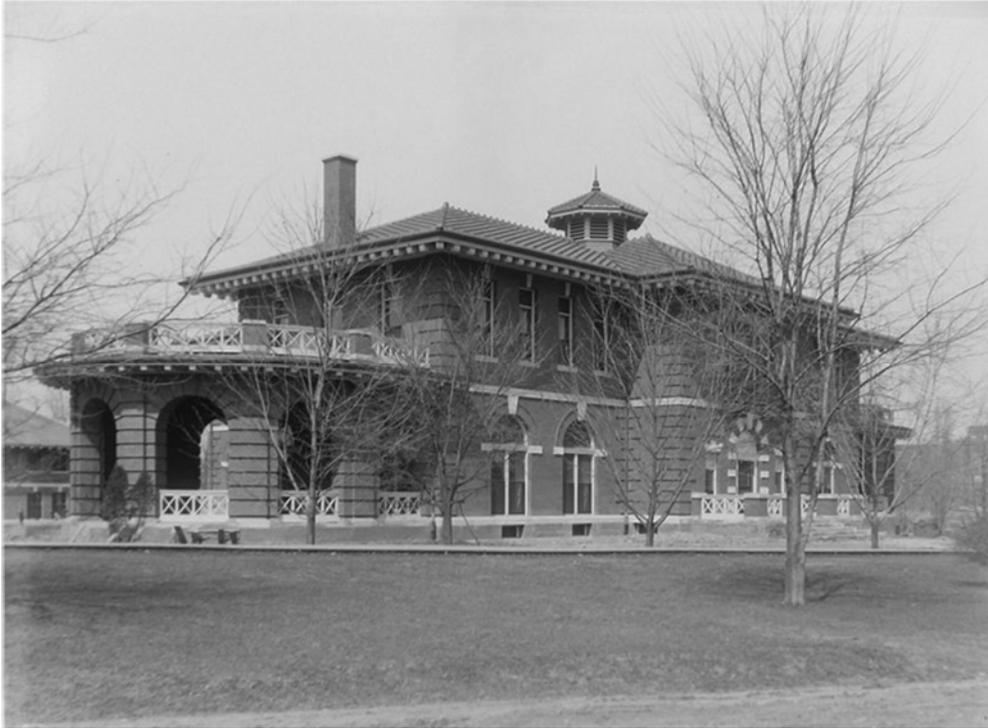
*Figure 15. View of the L Building from the southeast, circa 1905. Source: GSA archives, image DC0107SE0P020.*

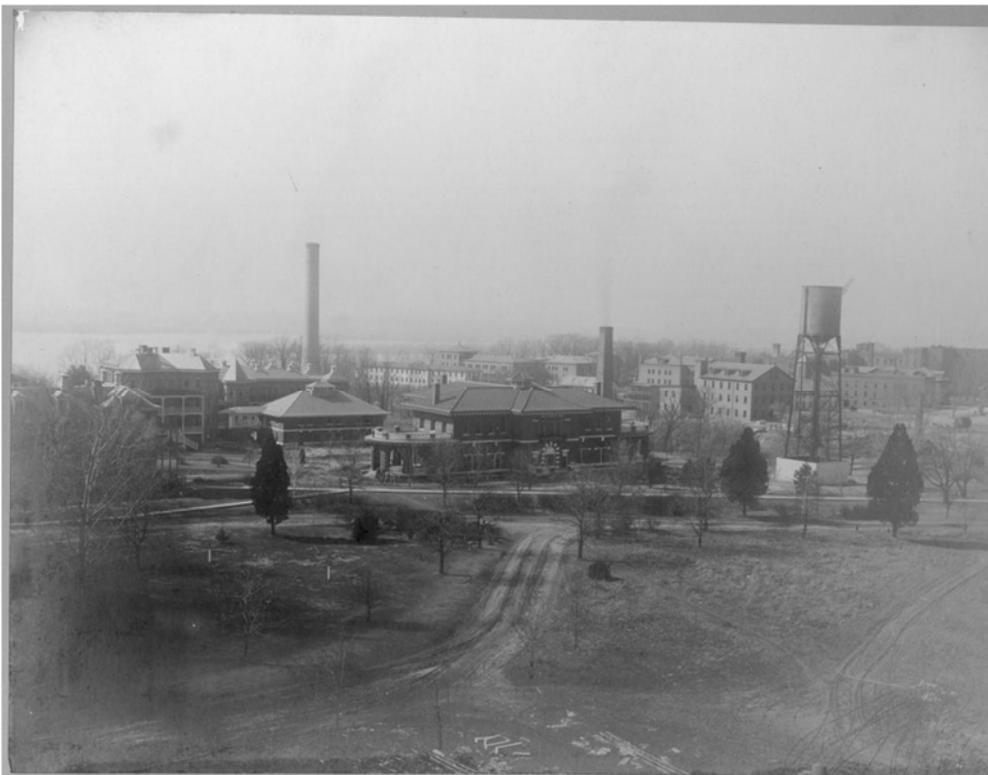
*Figure 16. Bird's eye view of the L Building, circa 1904. Source: GSA archives, image DC0107SE0P006.*
