ARLINGTON MEMORIAL BRIDGE

HAER No. DC-7

Location: Adjacent to the base of the Lincoln Memorial, Washington, D.C., spanning the Potomac River to Arlington Cemetery, Arlington, VA.

Date of Construction: Designed 1929, Completed 1932

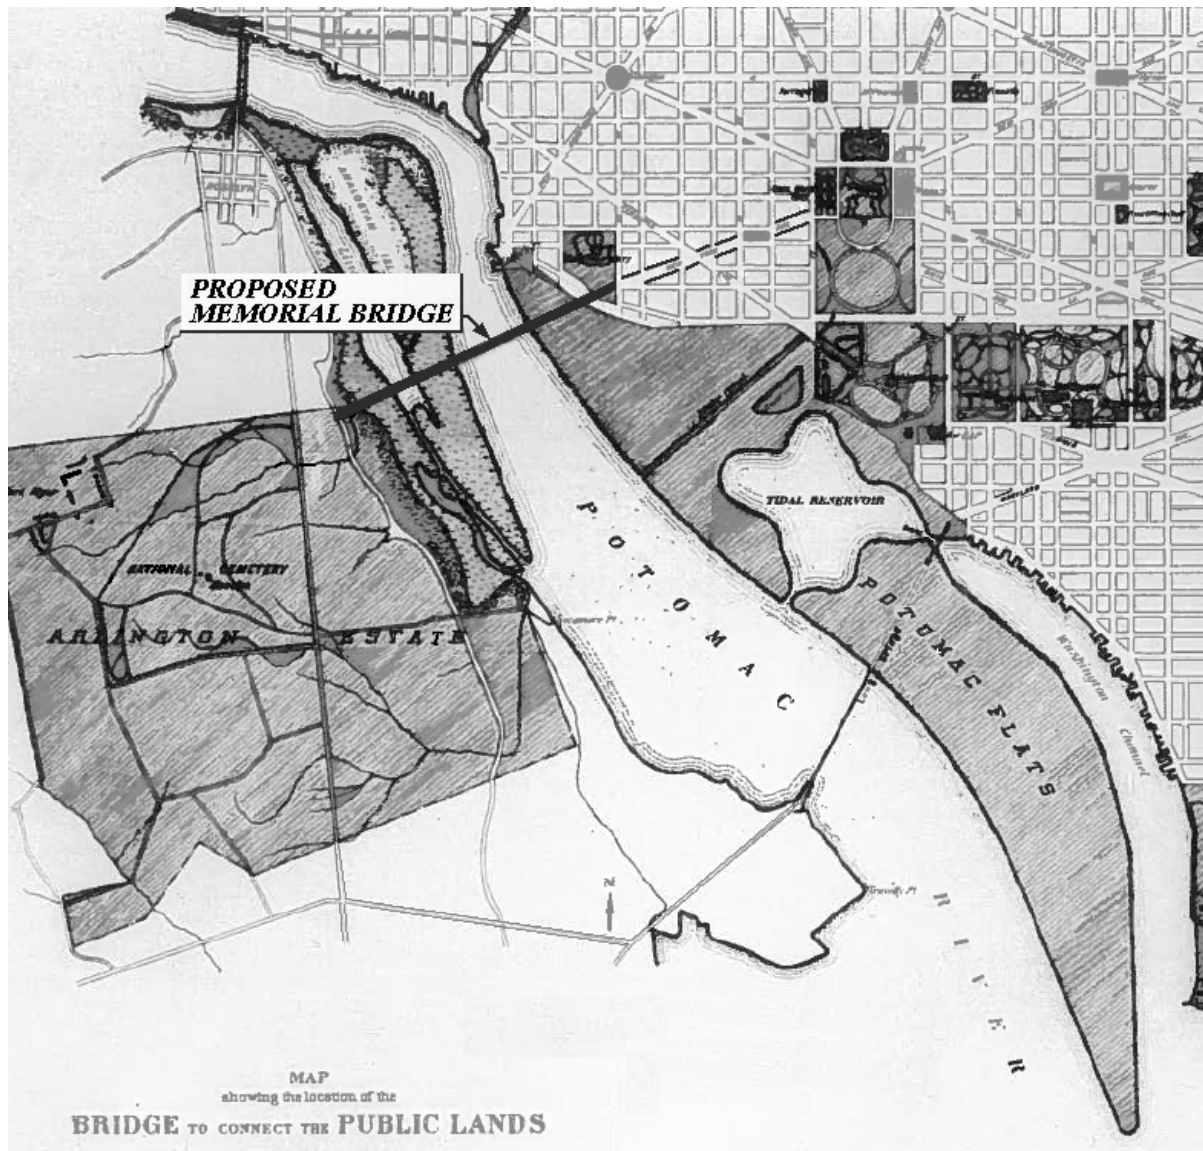
Figure 1. The initial location proposed for the Memorial Bridge was in line with New York Avenue. This was the best location before the Potomac Flats was reclaimed (shaded area), but it would not have entered Arlington National Cemetery in a desirable location. Some engineers claimed that this location would allow the bridge to be high enough that it would not need a draw span. This map is from 1890. (NARA RG 77, Cons. 722, No. 1)

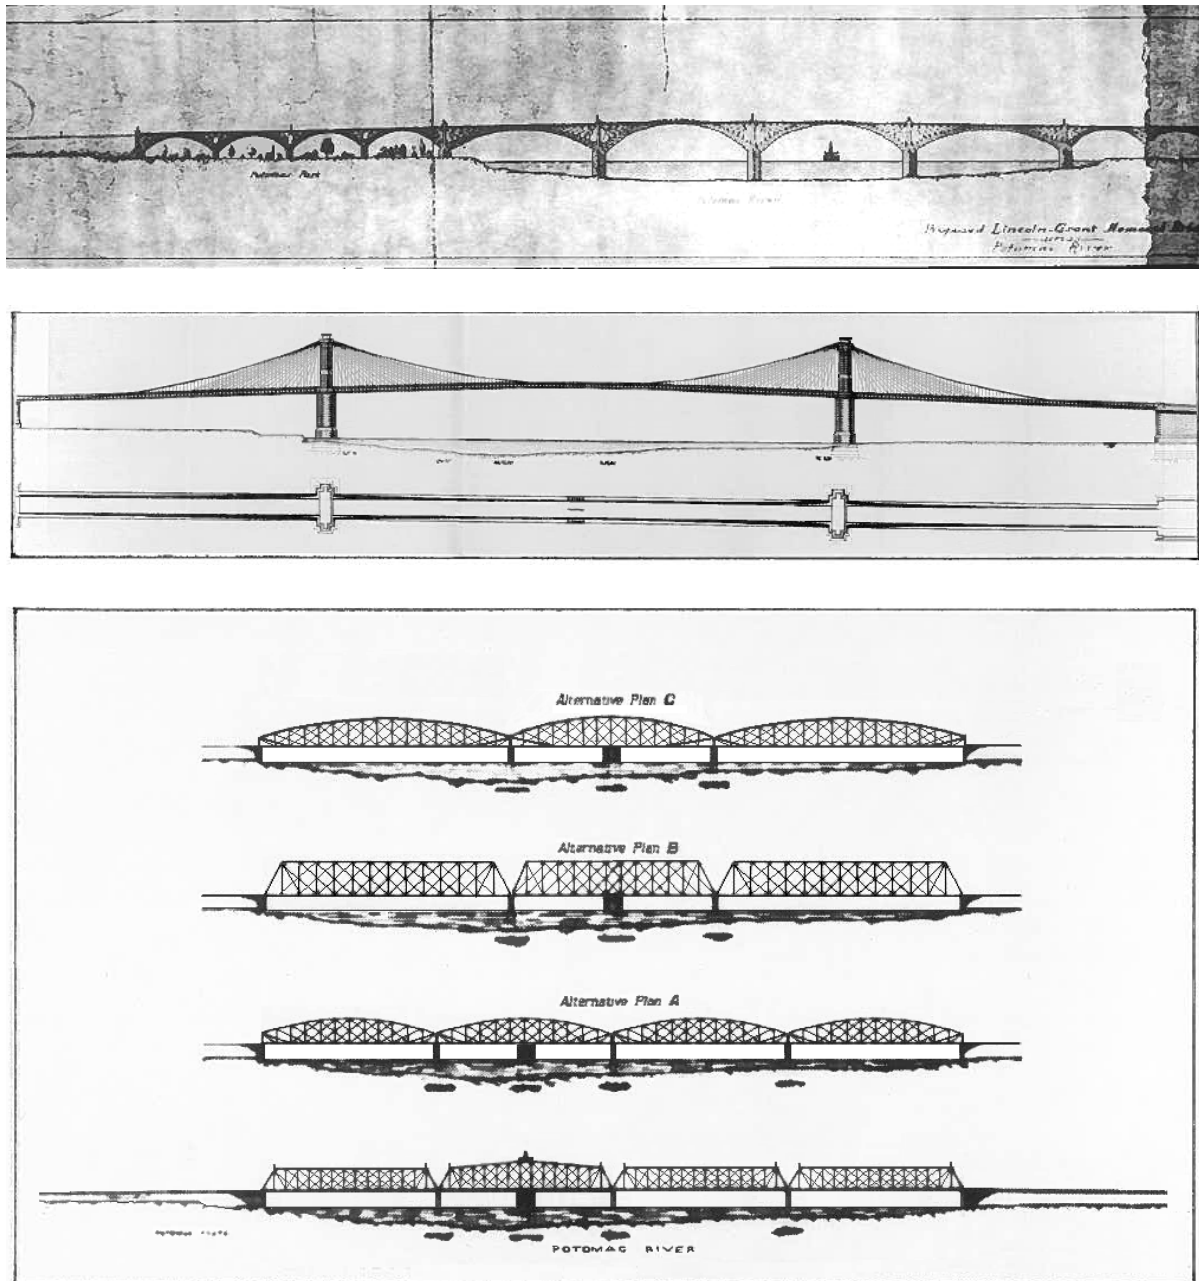
Figure 2. The first designs for a memorial bridge at the foot of New York Avenue exhibited a wide range of ideas. Army Capt. Thomas W. Symons proposed a fixed-arch “Lincoln-Grant Memorial Bridge” with an attractive profile (top), while Col. Peter C. Hains submitted a suspension bridge (center) high enough to clear river traffic and purely functional through-truss iron bridges with a swing span near the center (bottom). Hains included three- and four-span alternates, with one of each (A and C) employing lenticular trusses, a type rarely used in the United States. These designs were submitted between 1886 and 1890 in response to a Senate resolution. (NARA RG 77, Cons. 426, No. 2, and NARA RG 77 Cons. 722, No. 2. Also *U.S. War Department Annual Report, 1890* vol. 2 Appendix.)

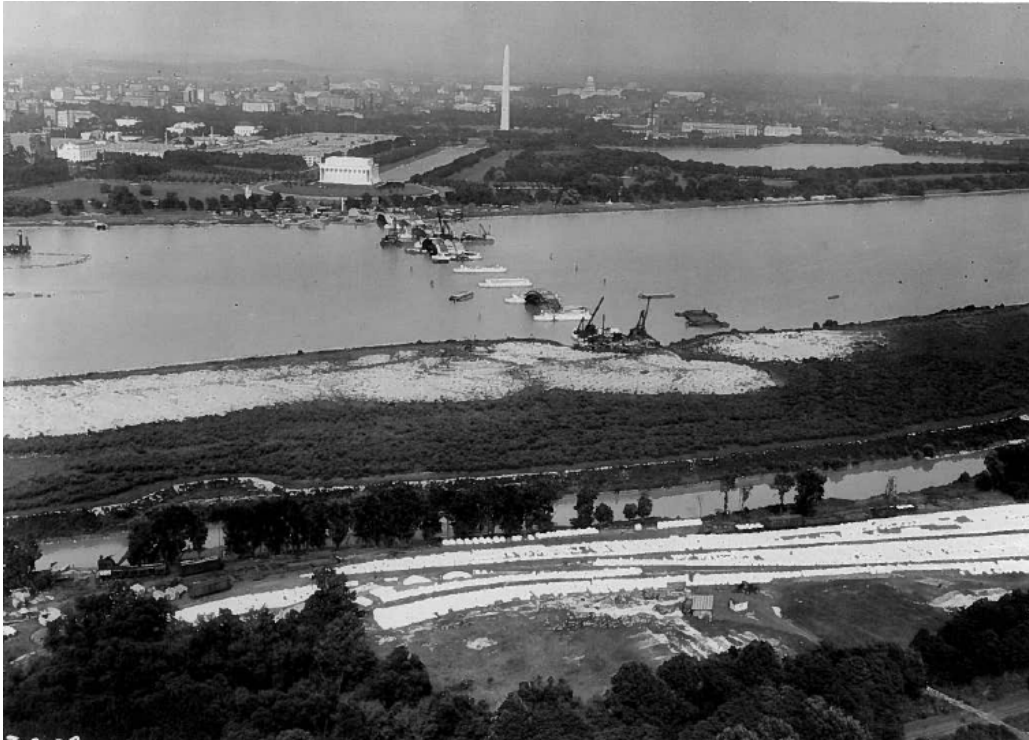
Figure 3. This aerial view in mid-1928 shows the pier foundations in place. The large storage area needed for the granite facing stones is in the foreground. (NARA RG 42)

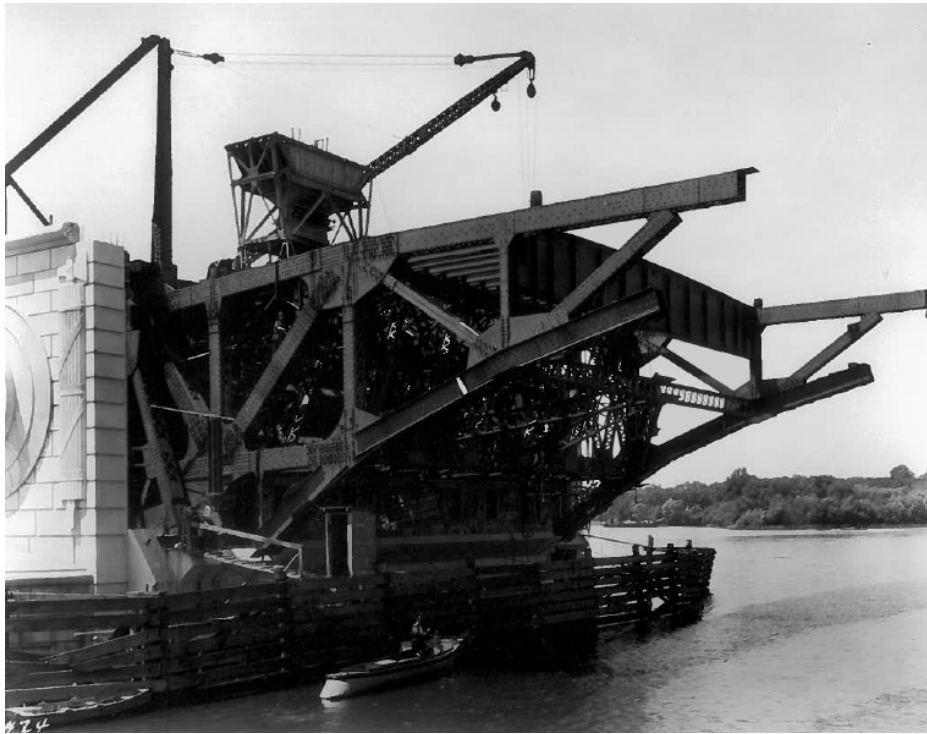
Figure 4. Each leaf of the bascule span was assembled with rivets from components fabricated at Phoenix Bridge's shop. The east leaf was erected first, and then raised to provide clearance for ships while the west leaf was being built. (NARA RG 42-AMB-1-30)
