U.S. NAVAL BASE, PEARL HARBOR, DRY DOCK NO. 4, EAST &  
WEST QUAY WALLS  
(U.S. Naval Base, Pearl Harbor, Naval Shipyard, Facilities Nos. O-2  
& O-3)  
East & west sides of Dry Dock No. 4  
Pearl Harbor  
Honolulu County  
Hawaii

HABS HI-518

### U.S. NAVAL BASE, PEARL HARBOR, DRY DOCK NO. 4, EAST & WEST QUAY WALLS (U.S. Naval Base, Pearl Harbor, Naval Shipyard) (Facility Nos. O-2 & O-3)

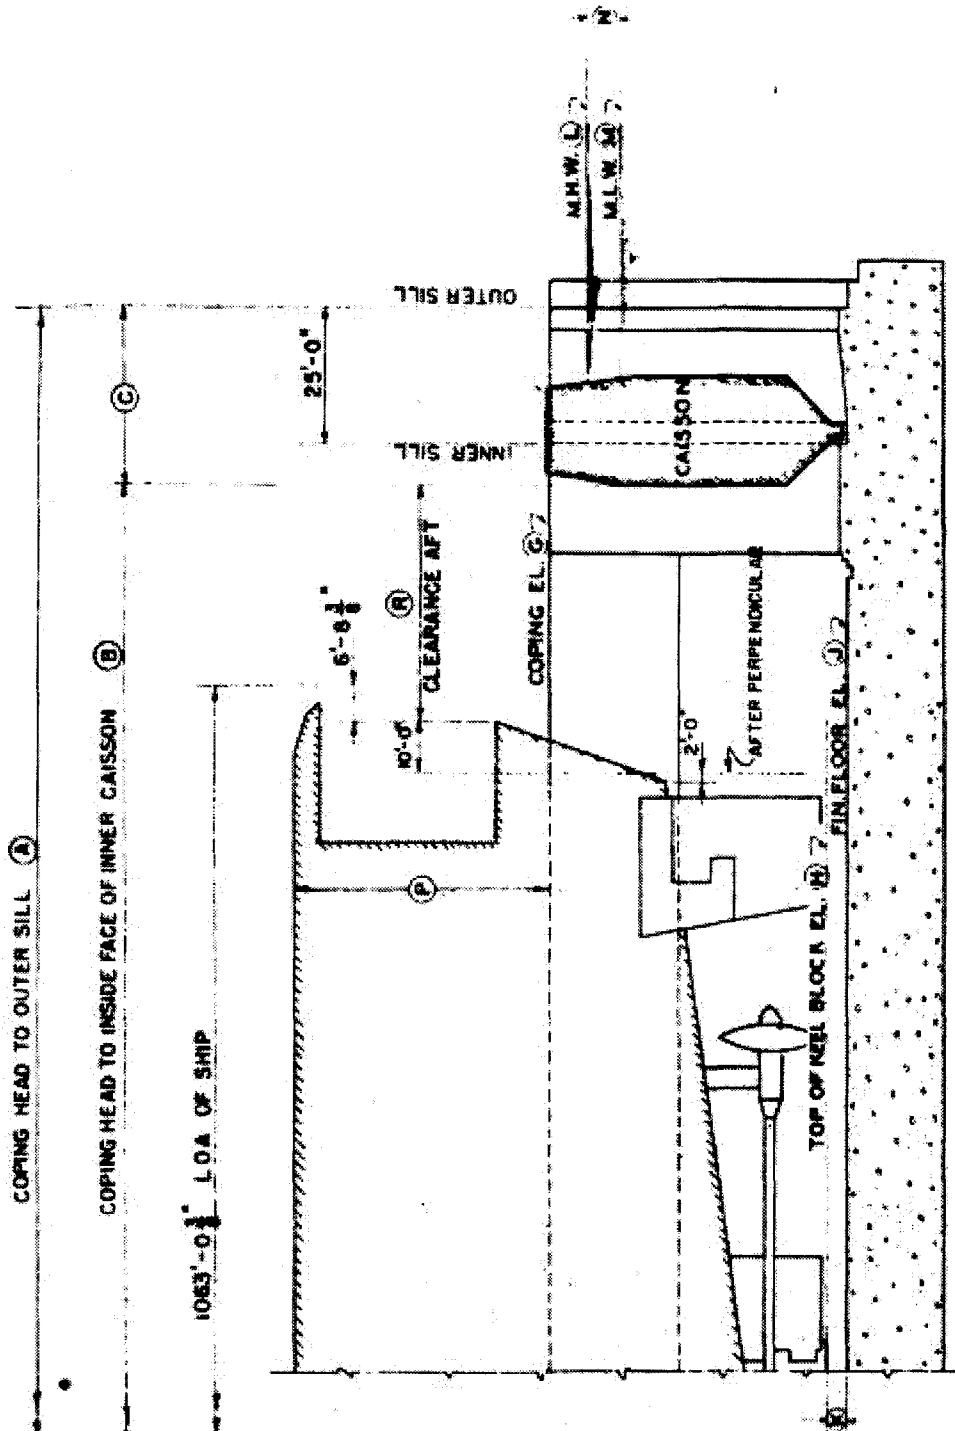
Longitudinal Section- Entrance End of Dry Dock No. 4  
(Drawing No. B-N22-284, dated 11/19/1941) (partial drawing, reduced not to scale)
