NEW YORK STATE BARGE CANAL, LOCK E28B
(Erie Canal, Lock E28B)
Clinton Street
Newark
Wayne County
New York

HAER NY-445
HAER NY-445

WRITTEN HISTORICAL AND DESCRIPTIVE DATA

NEW YORK STATE BARGE CANAL, LOCK E28B (Erie Canal, Lock E28B)

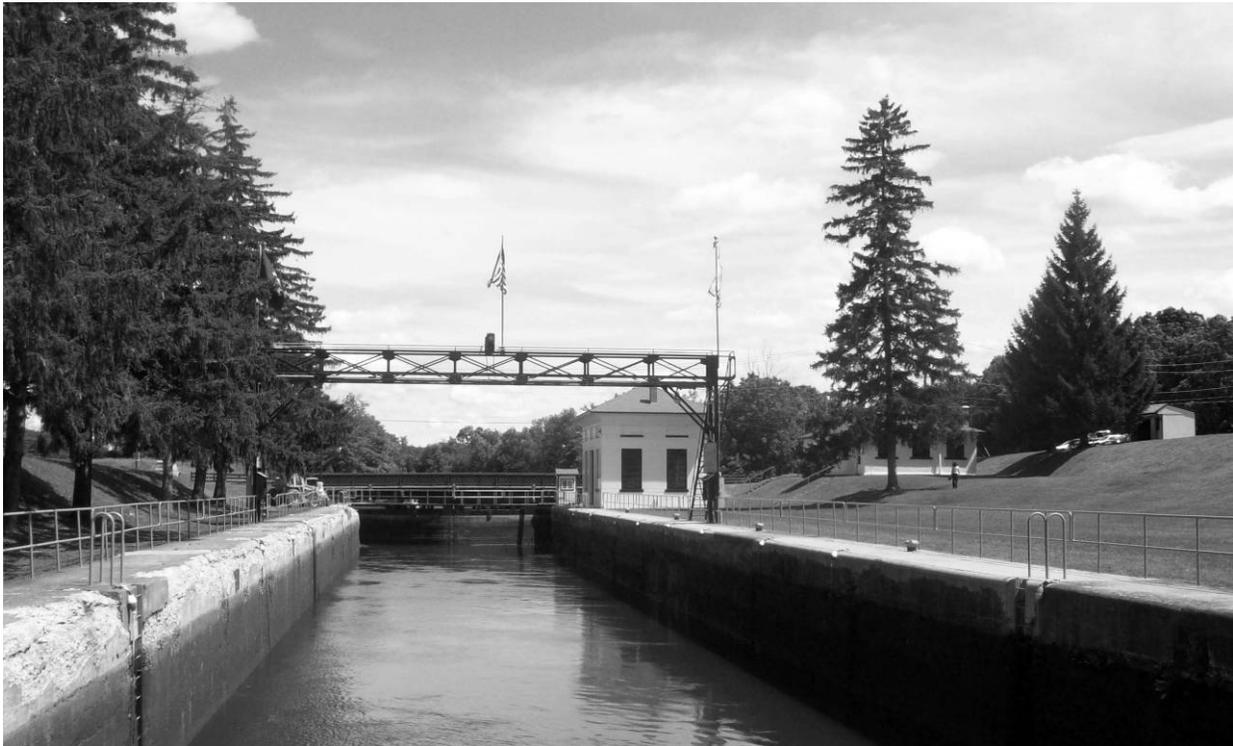
Image: Overview of lock with the powerhouse on the chamber wall, followed by the lockhouse, and the garage on the highest terrace. Field photograph taken by HAER recording team, summer 2009.
