FULLER PARK  
(Esteyville Common)  
Bounded by Estey Street and Pleasant Street  
Brattleboro  
Windham County  
Vermont

HALS VT-10  
*HALS VT-10*

WRITTEN HISTORICAL AND DESCRIPTIVE DATA

## HISTORIC AMERICAN LANDSCAPES SURVEY

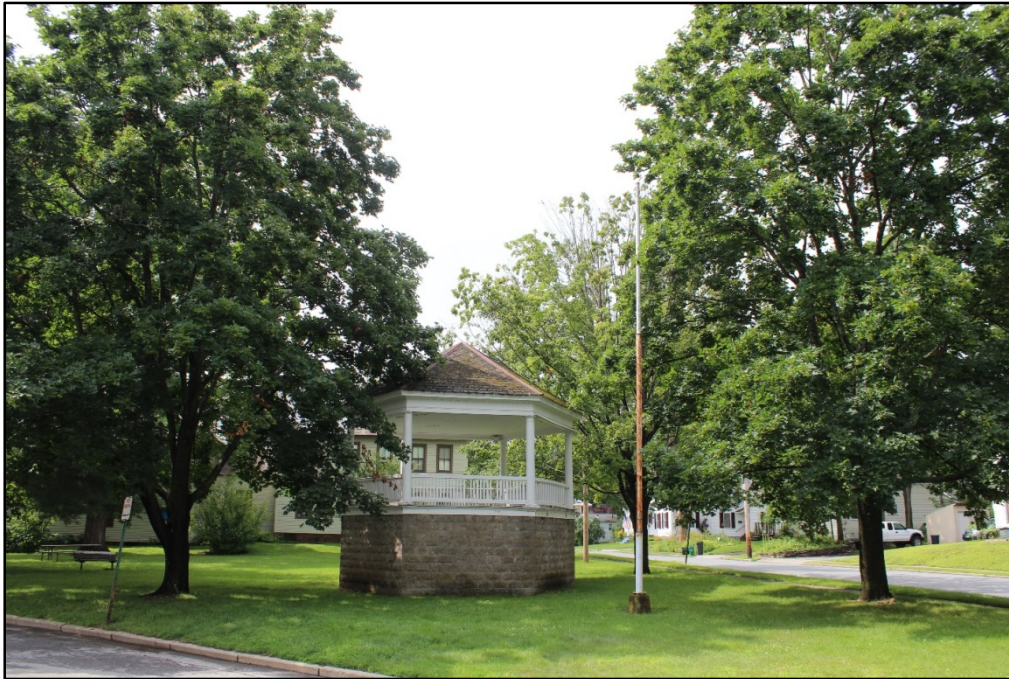
Photograph 5. View looking south into Fuller Park from Estey Street. Note the relationship of the flagpole, bandstand, and mature trees. (Devin Colman, July 2017)

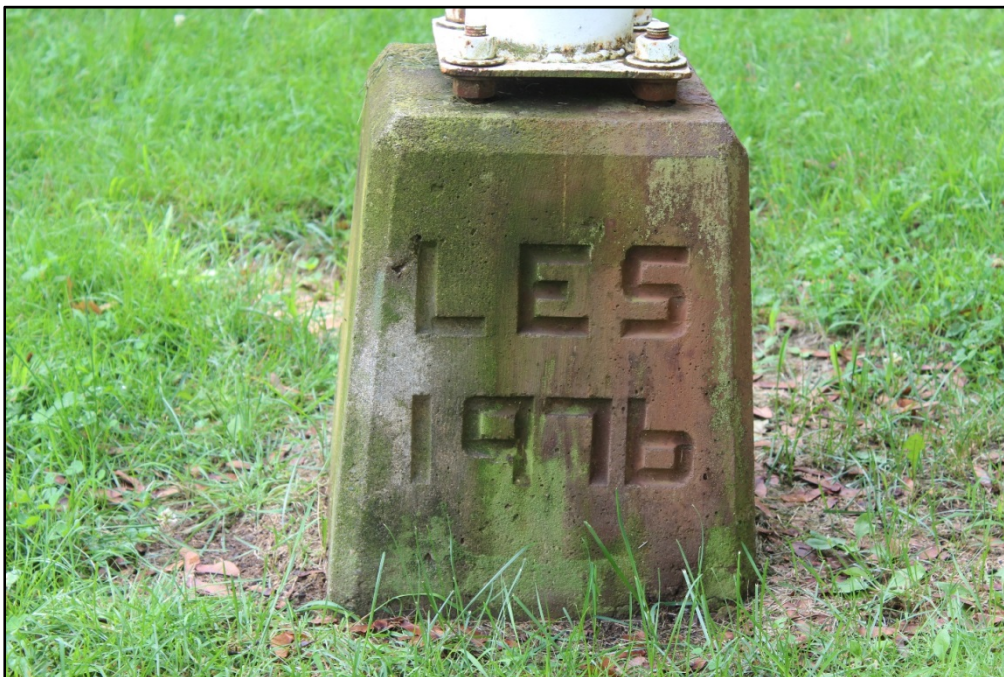
Photograph 6. Detail of concrete flagpole base, with “L E S 1976” inscribed. “L E S” refers to the “Ladies Enterprise Society of Esteyville”, an organization involved with the maintenance and upkeep of the park. The installation of the flagpole was most likely related to the nation’s bicentennial in 1976. (Devin Colman, July 2017)

A metal flagpole on a low, square concrete pedestal is set approximately 60' south of the northern tip of the park. The pedestal bears the following inscription, which is cast into the concrete:

L E S  
1976

“L E S” refers to the “Ladies Enterprise Society of Esteyville”, an organization involved with the maintenance and upkeep of the park. The installation of the

flagpole was most likely related to the nation's bicentennial in 1976.

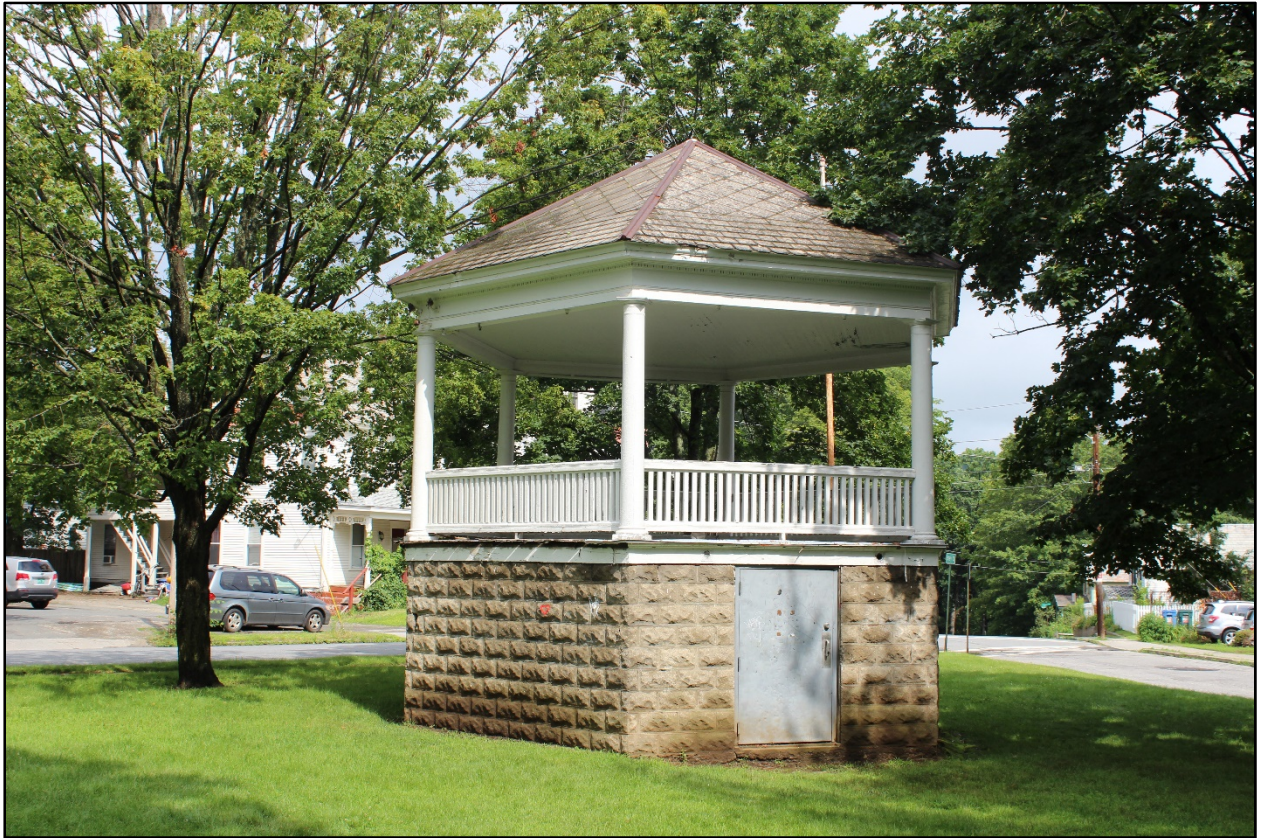
Photograph 7. View looking north at the bandstand from the center of Fuller Park. Note the rusticated concrete block foundation, the patterned-tile roof, and metal door leading into the base. Stairs in the base lead up to the performance platform. (Devin Colman, July 2017)

The bandstand is located approximately 16' south of the flagpole, equidistant from Estey Street and Pleasant Street. Unlike most bandstands in Vermont's town greens, which are elevated slightly above grade on low masonry footings or wood framing, the Fuller Park bandstand has an enclosed, hexagonal masonry base constructed of rusticated concrete block. The masonry base stands 7' high and has a small metal door on the south side to provide access to an interior staircase that leads up to the bandstand platform. Each side of the bandstand measures 11' 4" in length. The performance platform on top of the base is open on all sides and has a hexagonal pyramid roof supported by six Tuscan columns with Tuscan caps and bases. The columns support a full entablature with a dentilled cornice. The roof is clad with patterned tiles: the lower courses are laid in horizontal rows, with the first course of tile having clipped corners. The upper portions are laid in a diamond pattern. Between each column, on the underside of the entablature, there are two evenly spaced light sockets for bulbs that once illuminated the bandstand at night. A low balustrade with square balusters encloses the floor of the bandstand, which is made of wood. This is the second bandstand on the site, having been constructed in 1913-1914 to replace the original bandstand, which was removed in 1899.

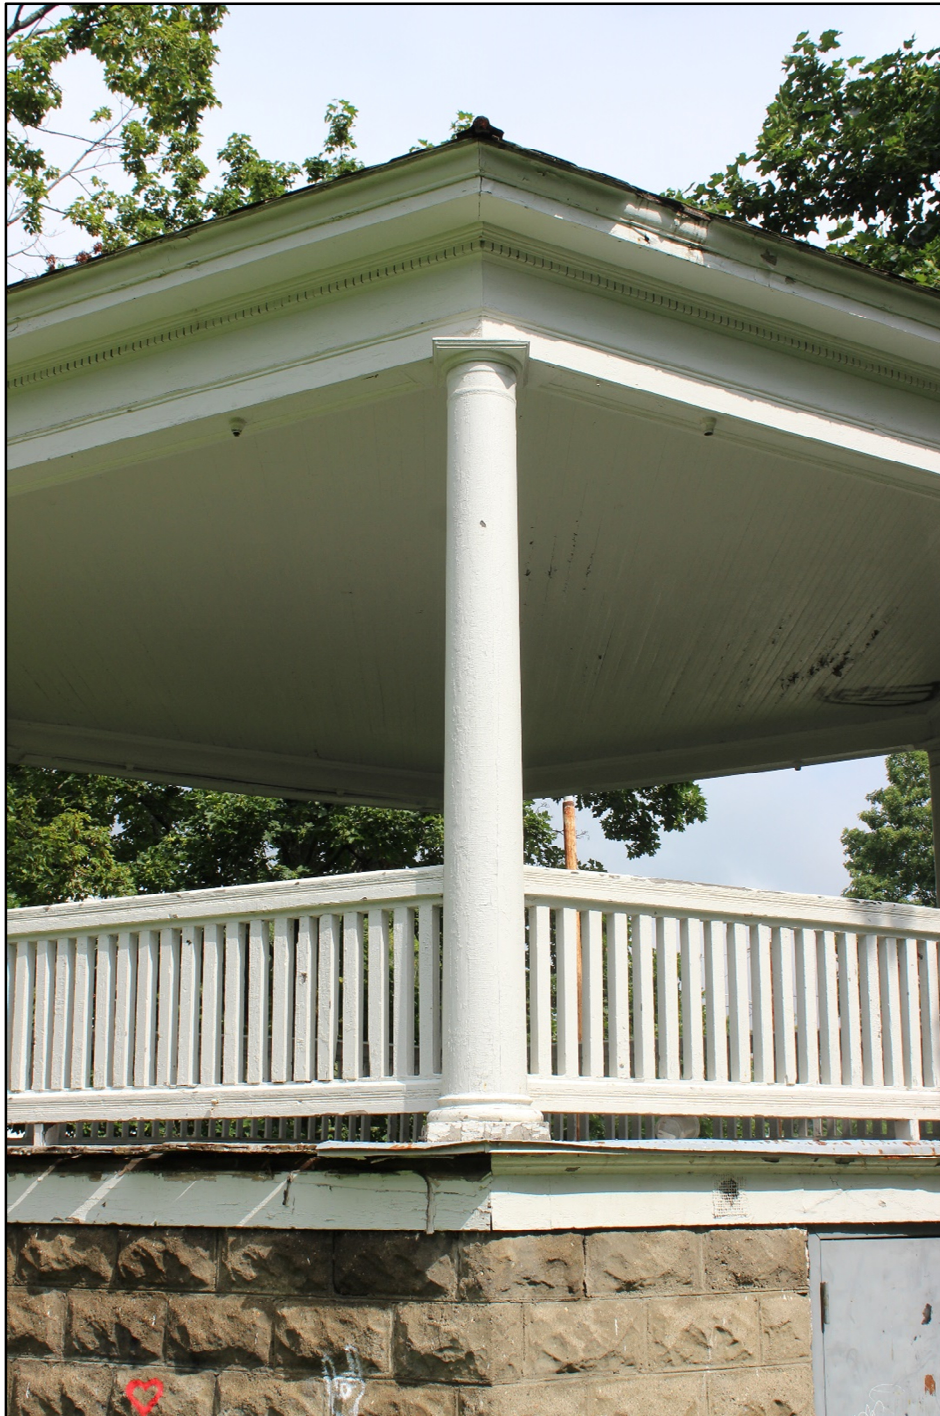
Consisting of grass and six trees, the landscaping of Fuller Park appears to be in fair condition. The focal point of the park, the bandstand, is in poor condition and is not being used due to safety and accessibility concerns. There is evidence of deterioration and rot on the trim and performance floor, and entire sections of molding are missing in several areas. A vertical crack at the southwest corner of the masonry base has damaged four of the rusticated concrete blocks, with one missing a large chunk from the face of the block. The rusticated concrete block base is an important character-defining feature of the bandstand, representing an early use of this material which was introduced in the early 20<sup>th</sup> century. There is graffiti on the bead board ceiling and on some of the blocks, and peeling paint in many areas.

Photograph 8. Detail of the bandstand showing rusticated based, Tuscan columns, balustrade, and entablature. Note the missing wooden trim piece from the edge of the performance platform, graffiti on the concrete block, and graffiti and peeling paint on the beadboard ceiling. Light sockets on the underside of the entablature once held bulbs for evening performances. (Devin Colman, July 2017)

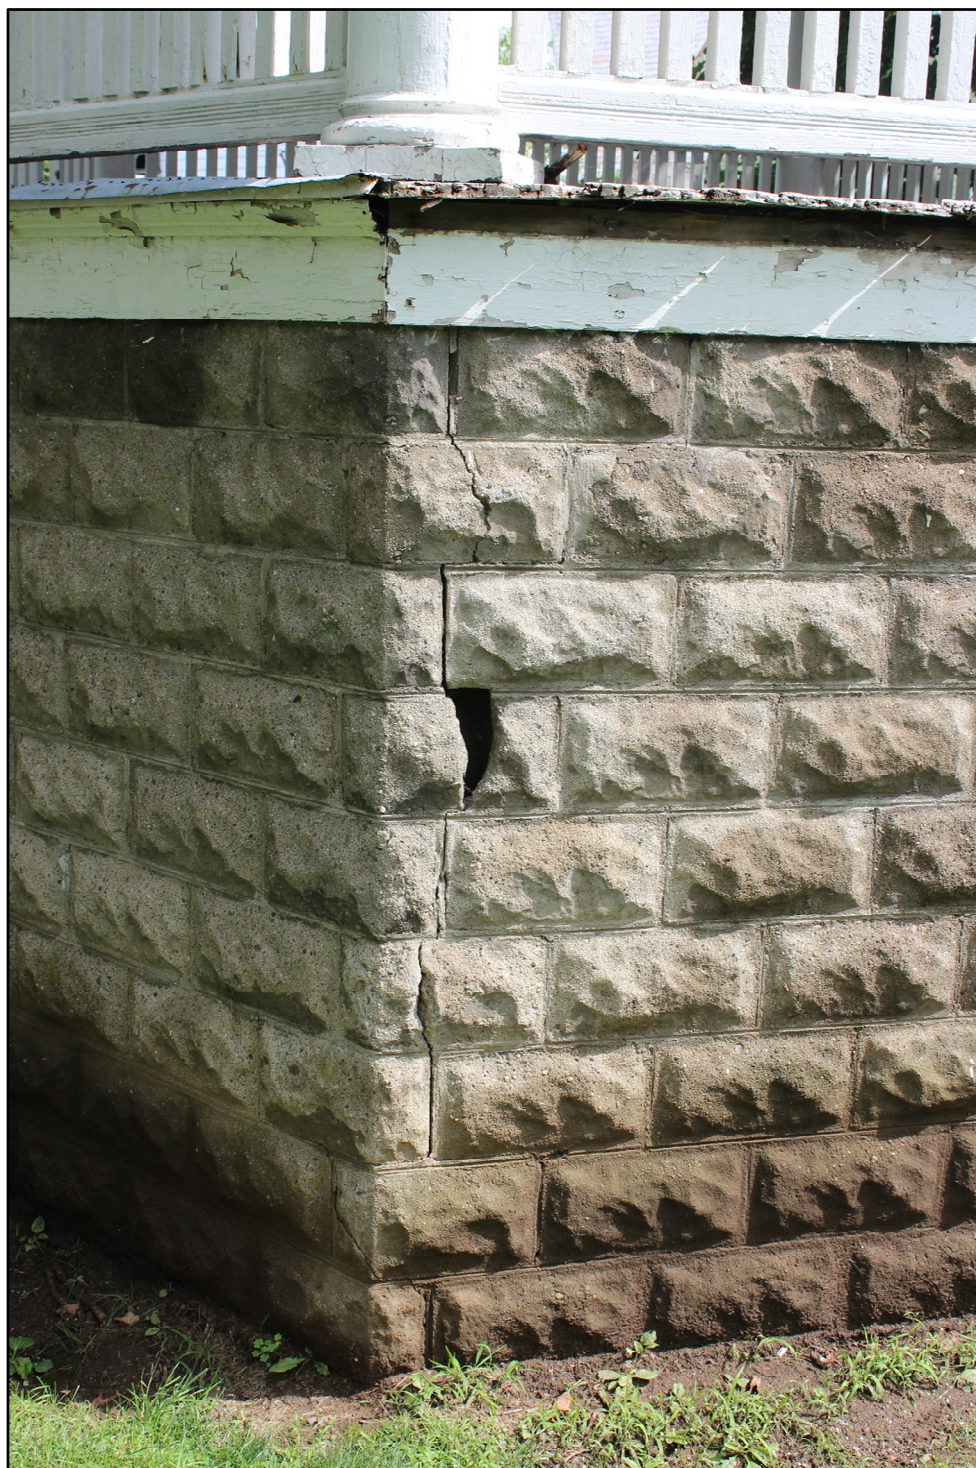
Photograph 9. Detail of south corner of bandstand showing vertical crack and resulting damage to the rusticated concrete block. Note the missing wooden trim piece from the edge of the performance platform and peeling paint. (Devin Colman, July 2017)

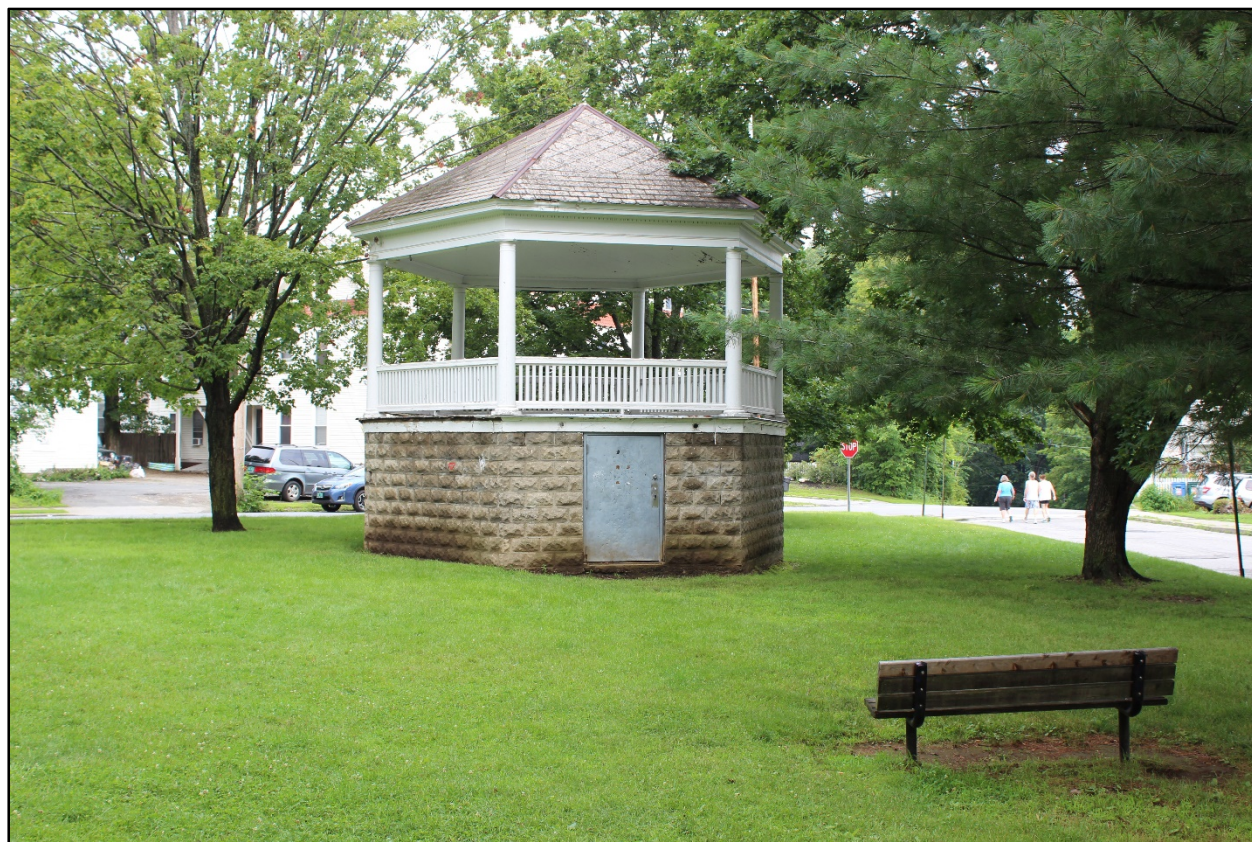
Photograph 10. View looking north from the south edge of Fuller Park, showing the relationship between the park bench, the bandstand, and trees along the edges of the park. (Devin Colman, July 2017)

The only other objects in the park are a wooden bench mounted on steel posts set in the ground approximately 20' southeast of the bandstand, and a portable picnic table set near the south edge of the park.
